RESERVE FUND STUDY

**LIBERTYDALE HOMEOWNERS ASSOCIATION
POWELL, OHIO**

*Revision 0
OCTOBER 7, 2022*

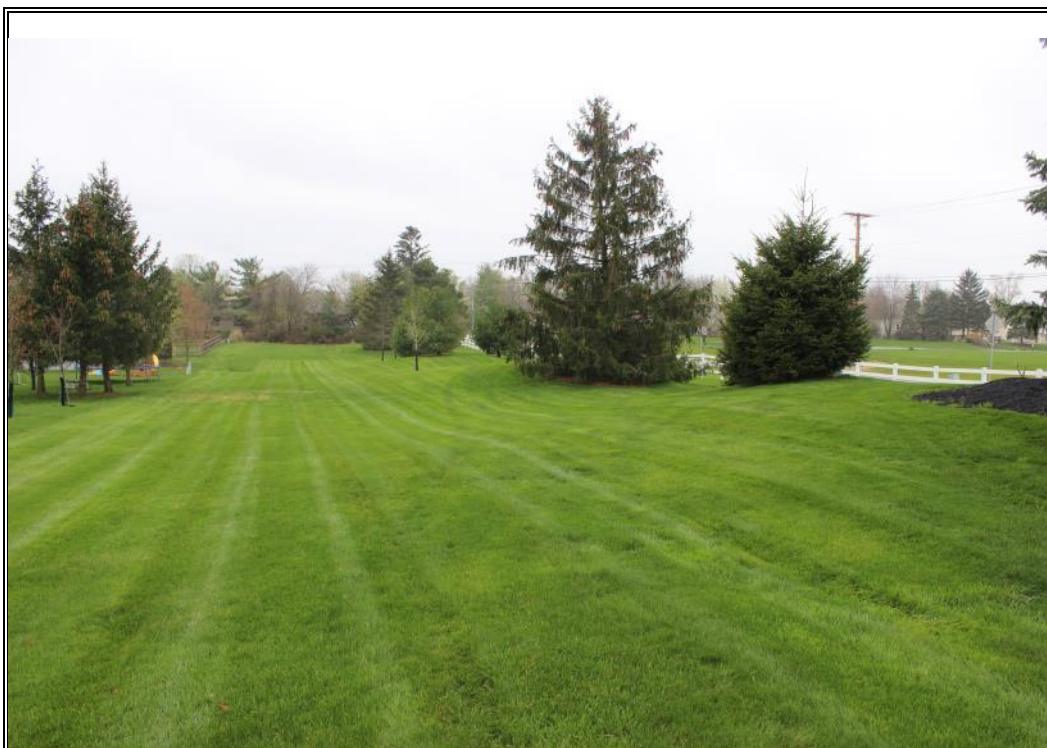
One of four community owned parcels. This parcel is south of the community entrance. Photo is looking south. This parcel contains approximately 19 mature trees and 9 newer trees.

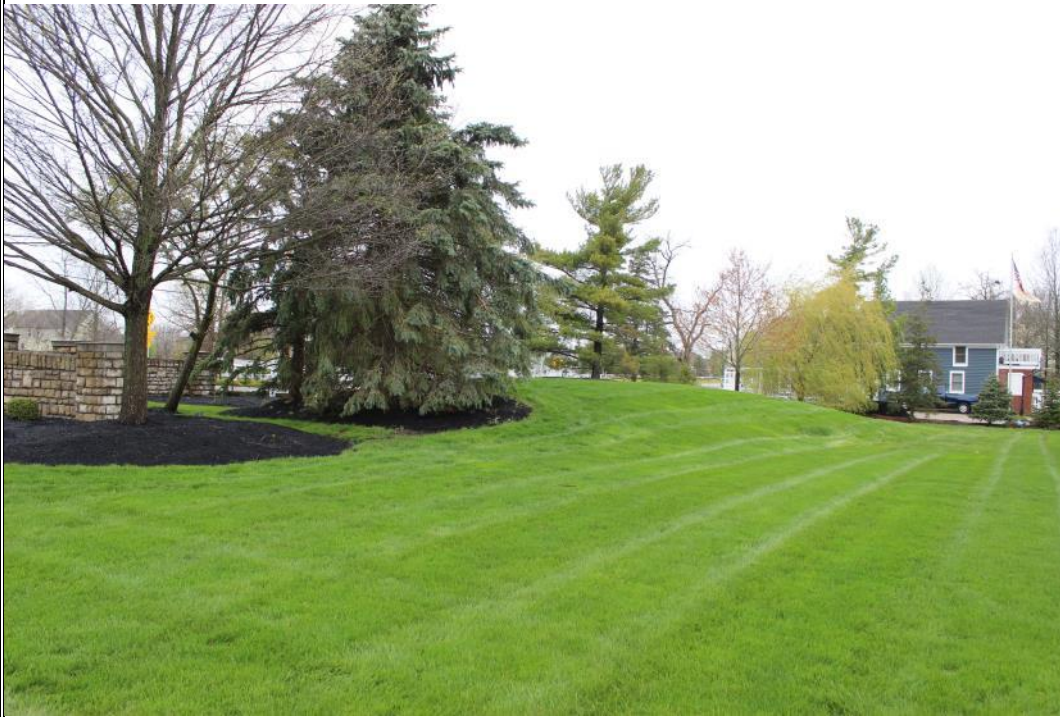
The community parcel north of the entrance, looking north. This parcel contains approximately 9 mature trees and 3 newer trees.

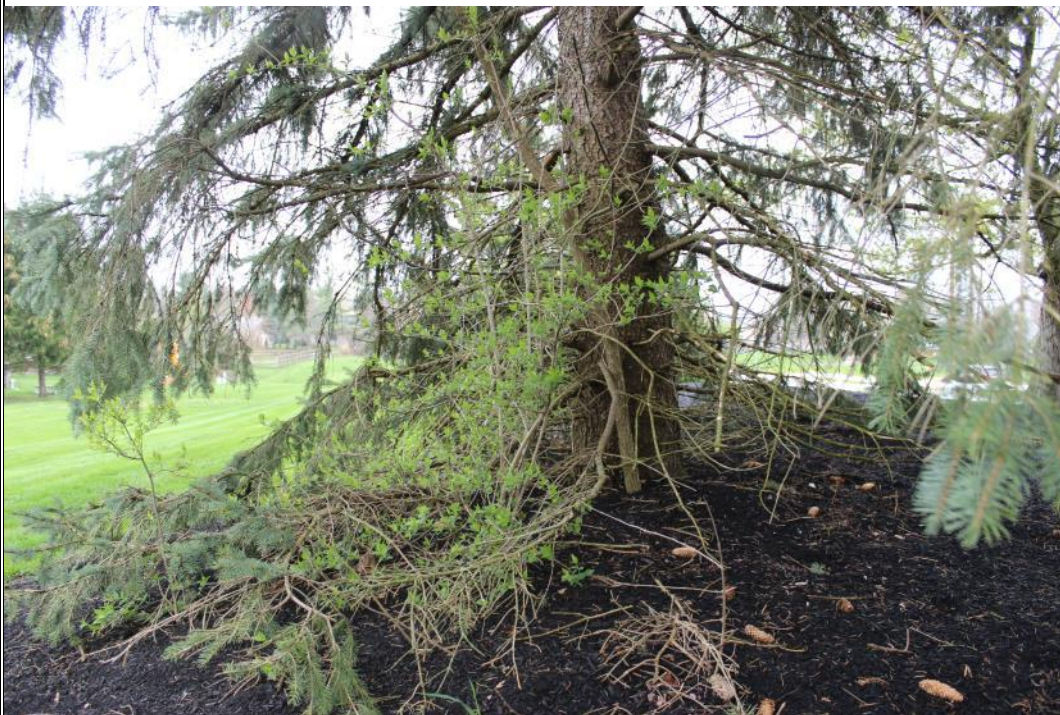
Weed trees and trees in need of pruning on the parcel south of the entrance.

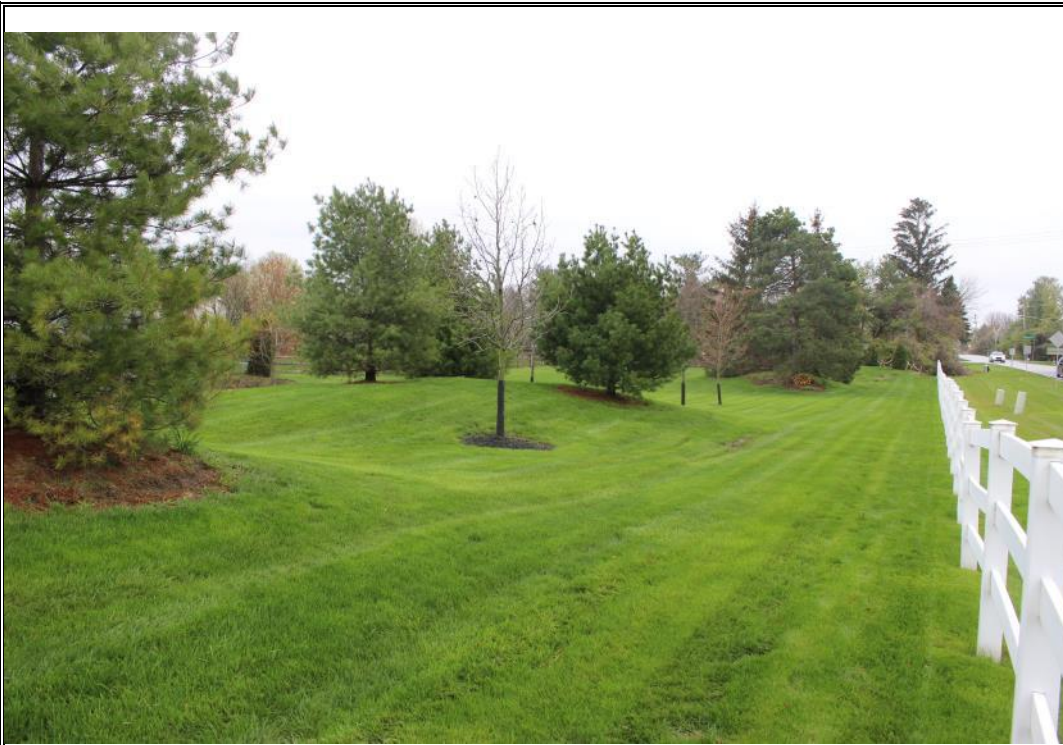
Photo Number
5

Description:
Example of more recently planted trees on the parcel south of the entrance.

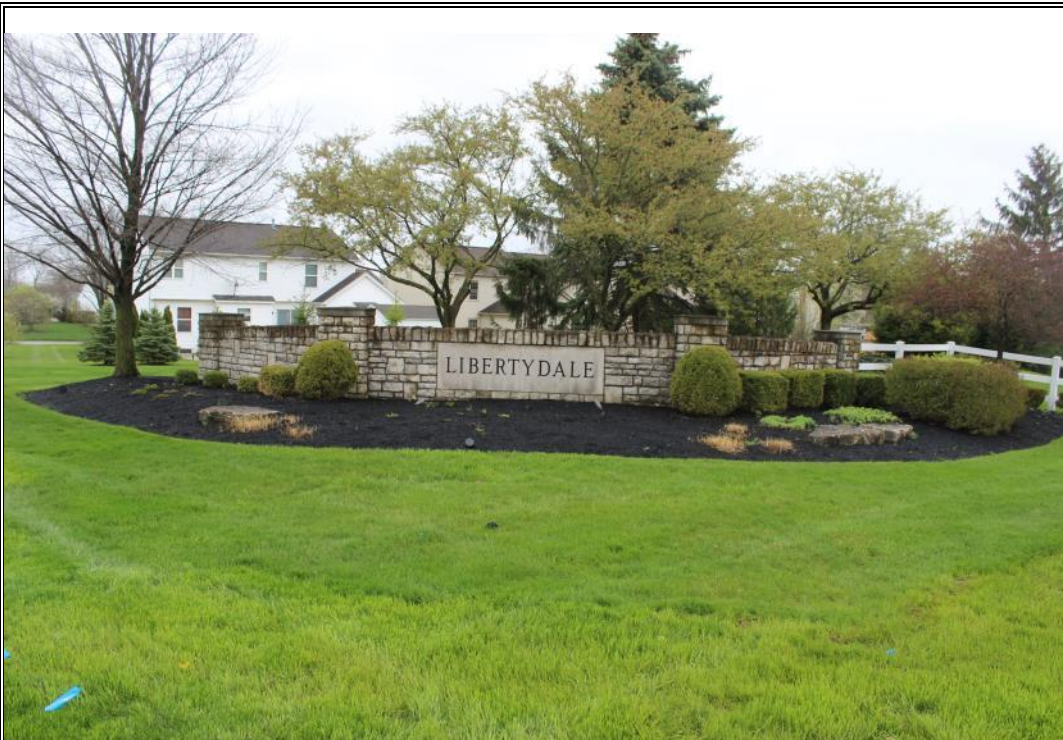
Photo Number
6

The stone veneer and masonry block walls and stone signage on each side of the community entrance are in fair to poor condition. Many of the stones have cracked or deteriorated, likely due to moisture that has entered the stone and frozen. Lack of continuous stone caps along the tops of the walls allows moisture to more quickly enter the stone veneer and mortar. These walls will continue to deteriorate in their present condition and repairs and replacement are needed in the near future. Funds to repair and replace these stone walls have been included in the study. Funds to add continuous stone caps along the tops of the walls have been included in the study. This work has been included in the study about three years out to allow enough time for sufficient reserve funds to be built up, although the association may elect to look at alternatives to this plan. The condition of the supporting masonry block wall behind the stone veneer and the supporting concrete foundation could not be verified. It was assumed in this study that partial repairs will be needed to the supporting masonry block wall behind the stone, but not full replacement. Additional funding is also included in future years for periodic cleaning and repairs of the stone walls.

Description:
Stone entrance wall and sign south of the entrance at Libertydale Dr.

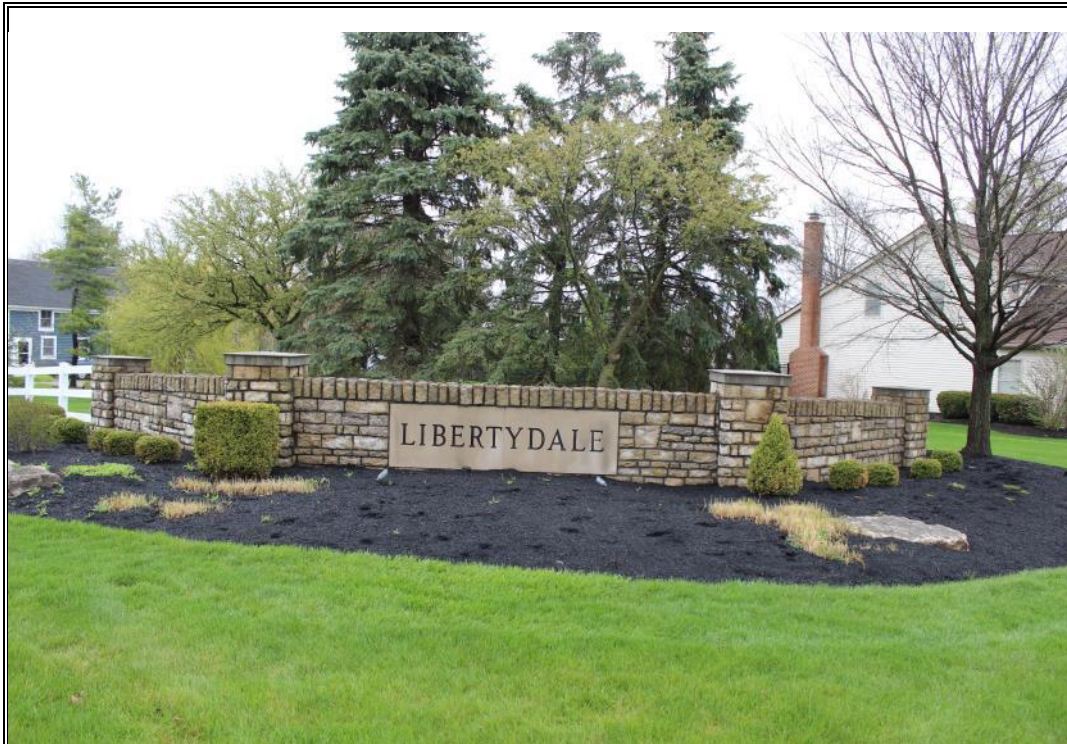
Photo Number
7

Description:
Stone entrance wall and sign north of the entrance at Libertydale Dr.

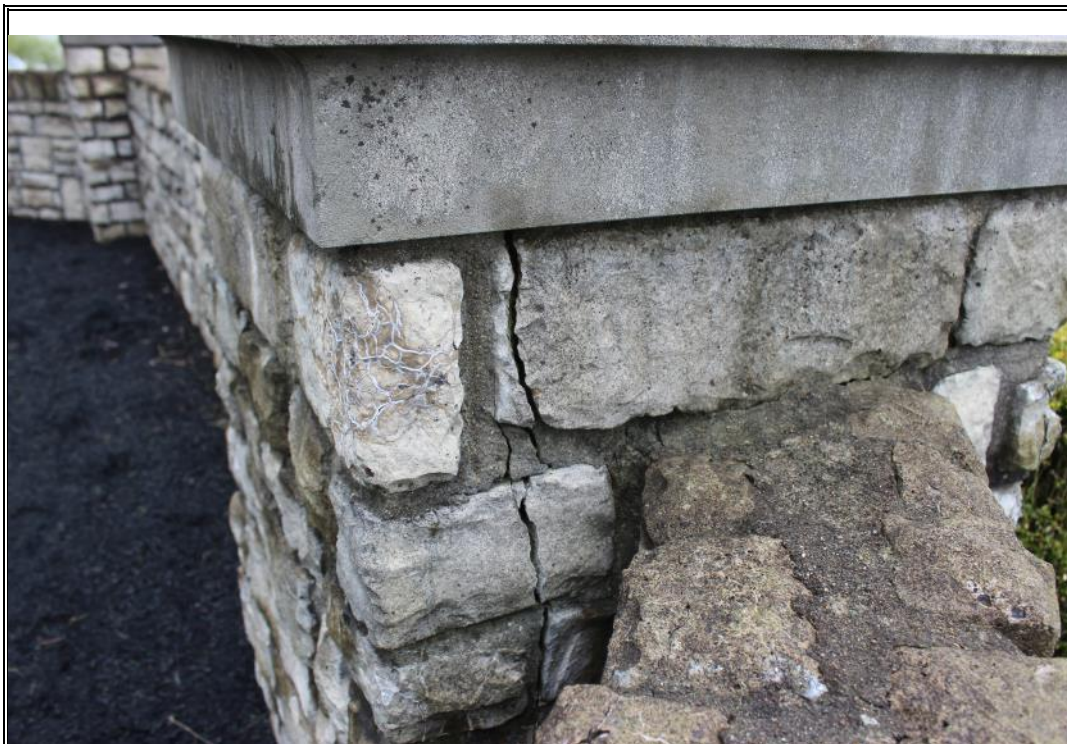
Photo Number
8

Description:
Example of observed cracking in the stone walls. Freezing moisture is likely the cause of the stone work deterioration.

- The entry stone walls are deteriorated and will need replaced in the near future.

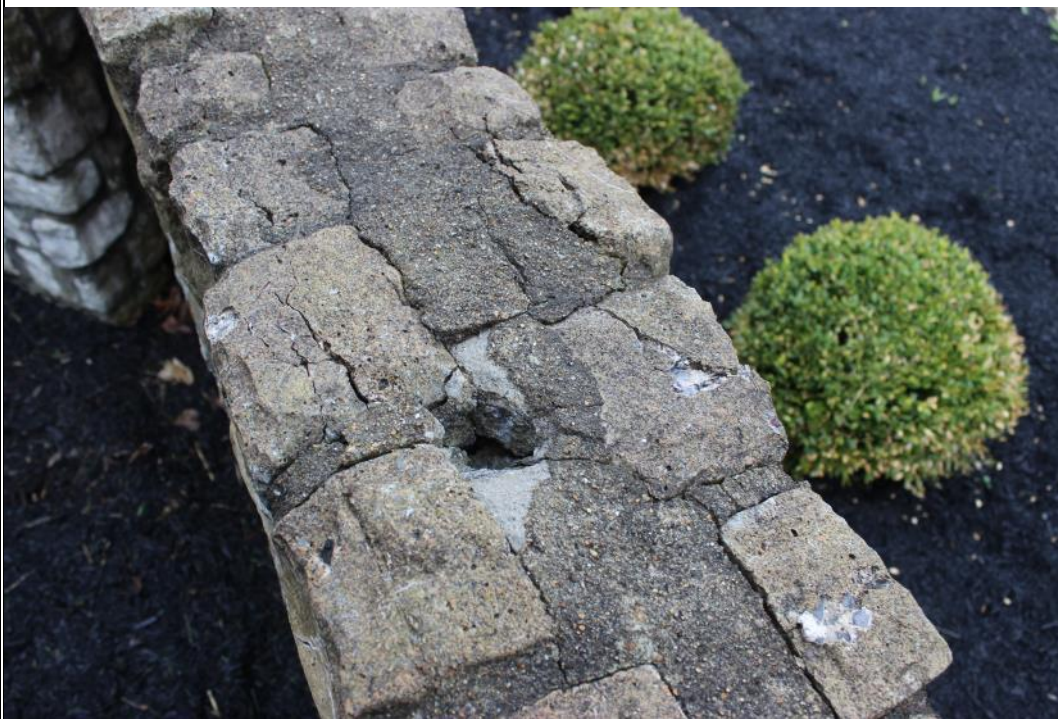
Photo Number
9

Description:
Example of deterioration observed on the top of the stone walls.

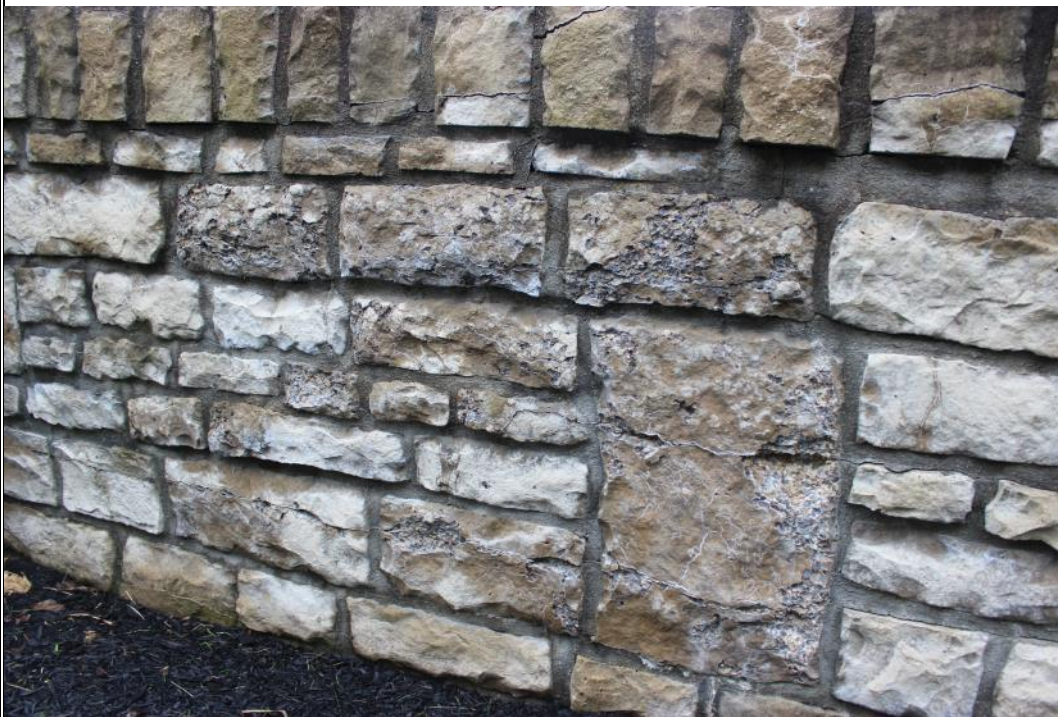
Photo Number
10

Description:
Example of observed deterioration of the stone walls.

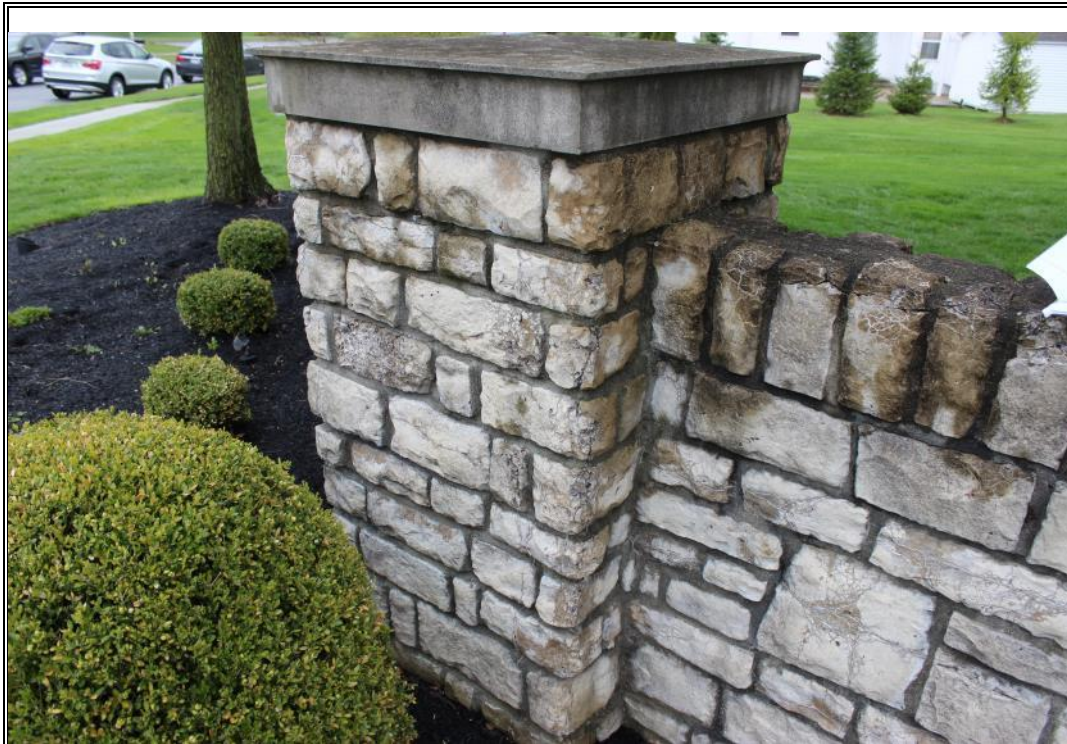
Photo Number
11

Description:
Example of
observed
deterioration of the
stone wall pillars.

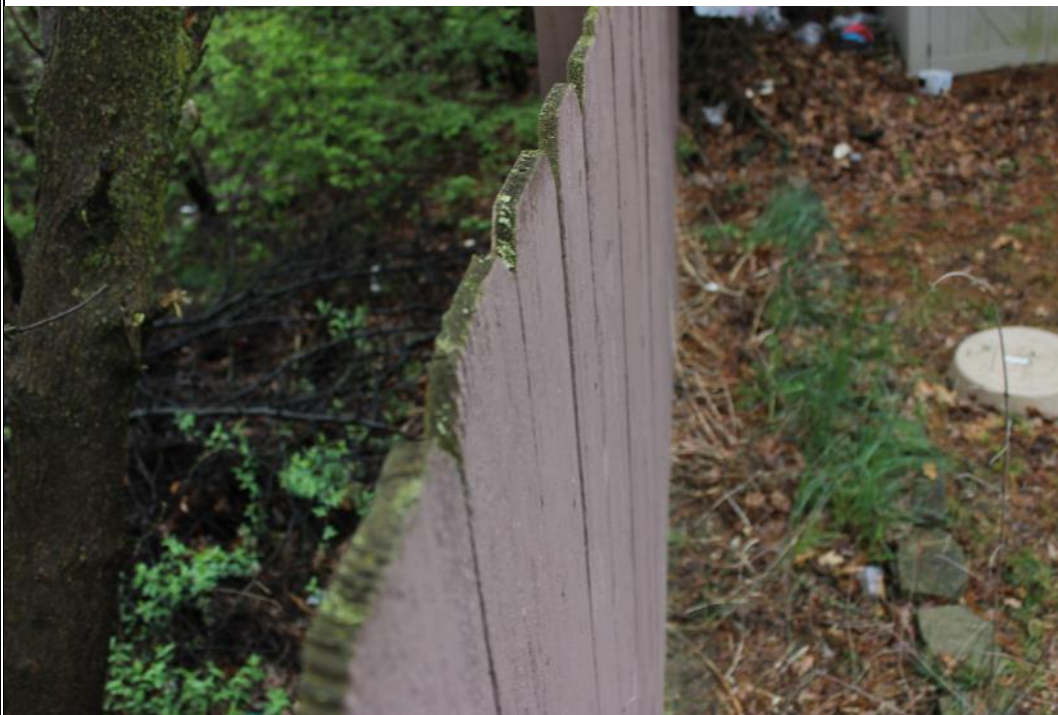
The wood privacy fence along the north portion of the east community boundary along the rail-line was in fair condition. The tops of the pickets were generally found to be un-sealed and wood rot has started to occur. The tops of the rails had mildew growth. A few pickets were missing, and some of the pickets are making contact with ponded water near the base at the south end of the fence. Proper surface preparation and sealing of the tops of the pickets will generally extend their useful life. Improvements to the fence to ensure the base of the fence is not in ponding water need to be completed. Funds to periodically repair and seal this fence have been included in the study. Periodic component replacement and re-coating rather than periodic full replacement is the approach taken in this study, but proper maintenance using the repair funds allocated in this study must be performed under this approach.

Moss and organic build-up on the top of the individual wood pickets of the privacy fence. This is a common location of deterioration and rot for this fence type. Sealing this surface will likely prolong the life of the fence.

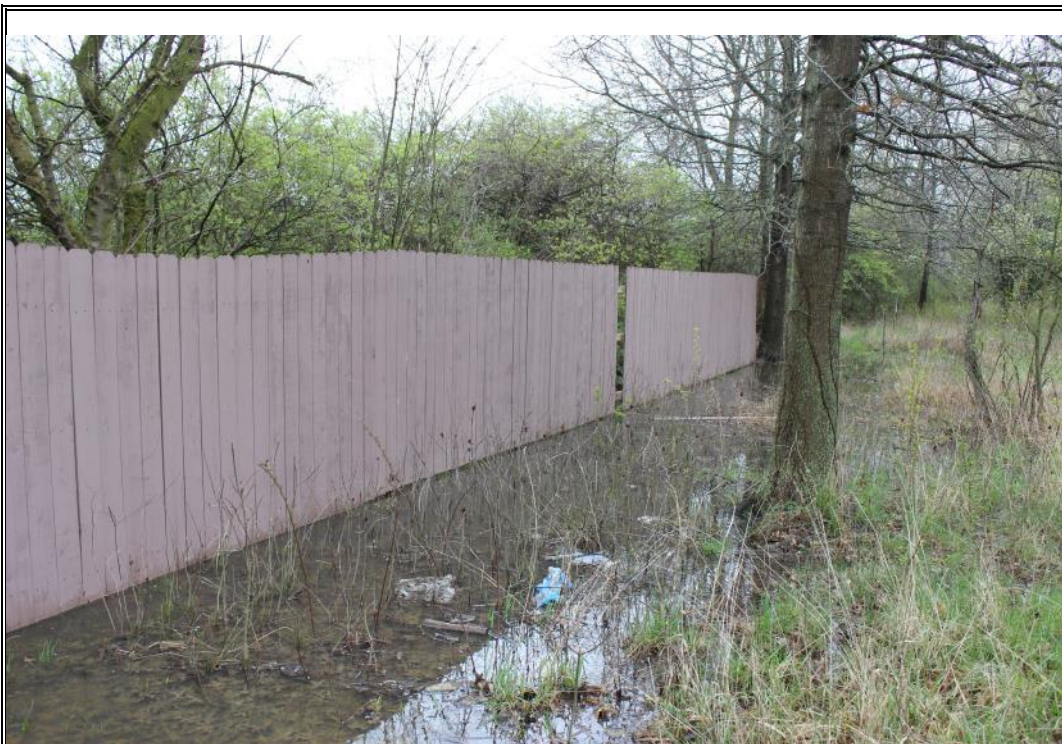
Photo Number
16

Description:
South end of the wood privacy fence. Note the missing vertical pickets and the ponding water.

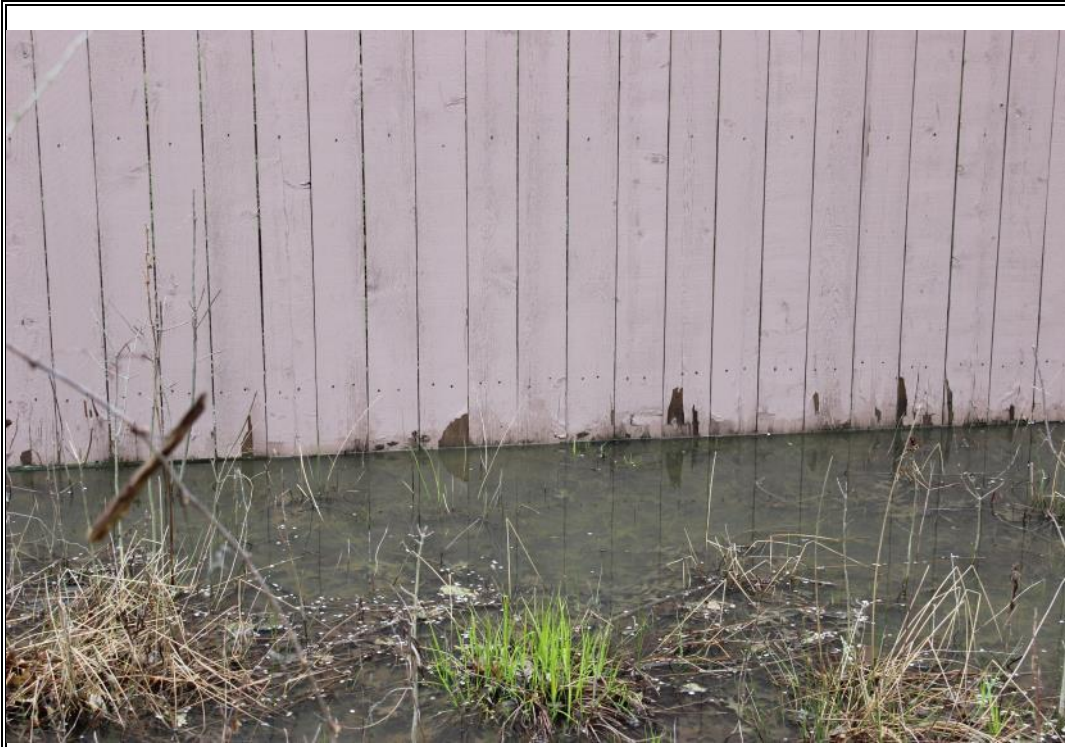
17

The ponding water near the south end of the wood privacy fence makes contact with the bottom of several of the pickets and surrounds the wood posts. Coating deterioration is occurring near the base.

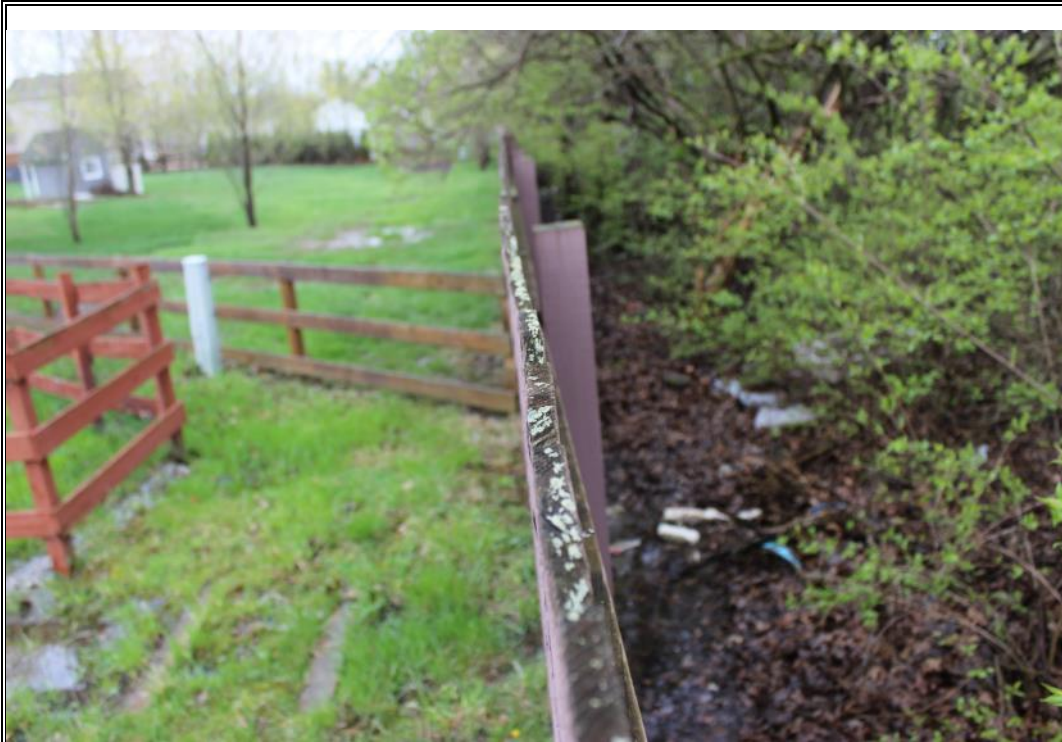
Photo Number
19

Description:
Top of picket
organic growth at
the south end of
the wood fence.

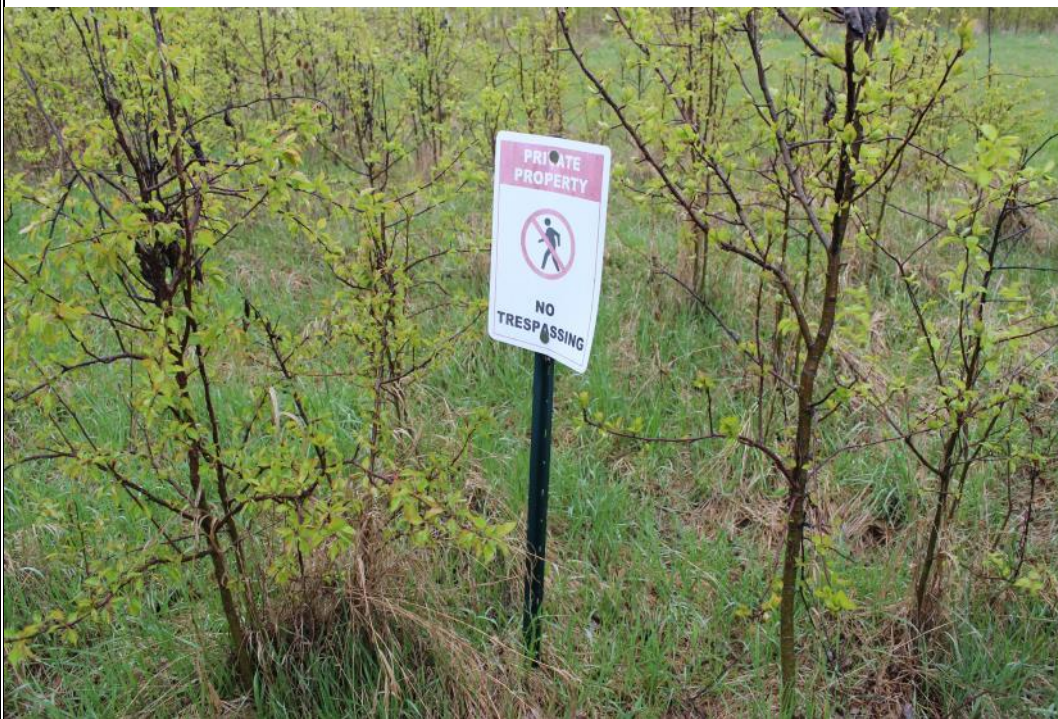
Photo Number
25

Description:
One of several dozen no trespassing signs along the south and west borders of the nature area parcel, located near the parcel boundary.

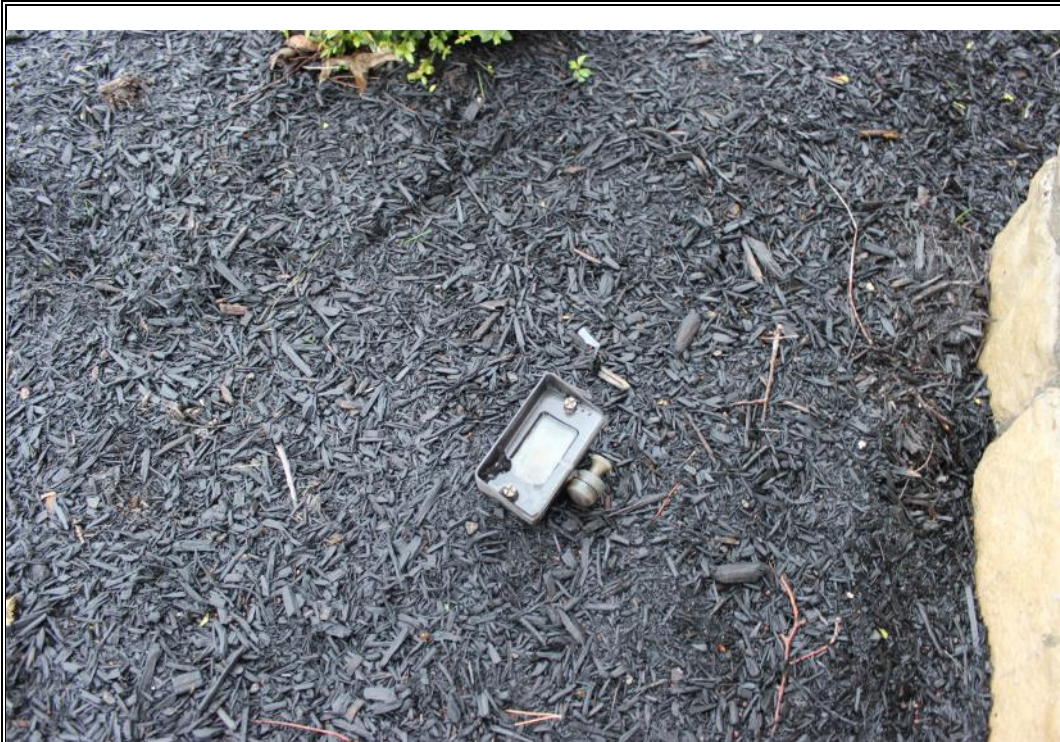
Photo Number
35

The landscaping lighting system was not tested, but appeared in good condition. Most of the lights showed signs of typical deterioration. Funds for the periodic replacement of the landscape lighting system around the entry stone walls have been included in the study.

Description:
Example of the low voltage landscaping light adjacent to the stone wall at the community entrance. There are approximately a dozen lights at each stone wall.

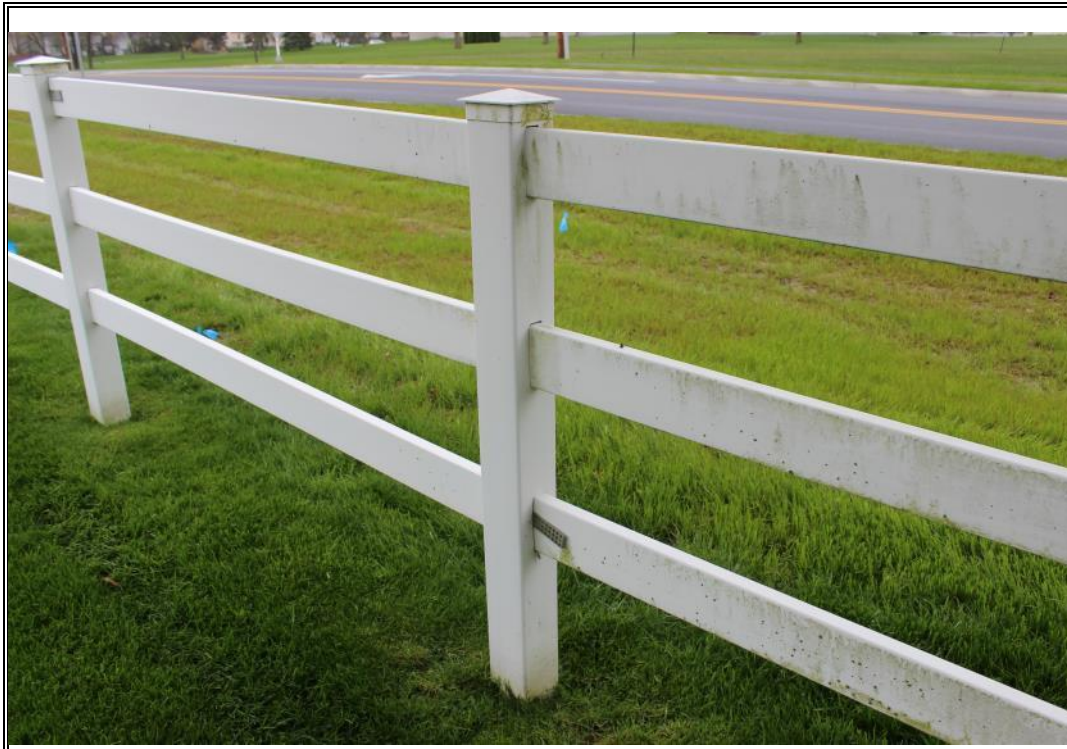
Photo Number
39

Vinyl 3-rail fencing was located along the west edge of the property, on both the south and north sides of the community entrance. A small number of areas of damage and rail shimming were observed along these fence lines. Vinyl fencing has a long useful life, but is prone to damage. Funds to periodically replace this fencing have been included in the study. The vinyl fence should be periodically repaired using annual operating funds until replacement.

Description:
Example of some rail shimming with plastic wedges that was observed.

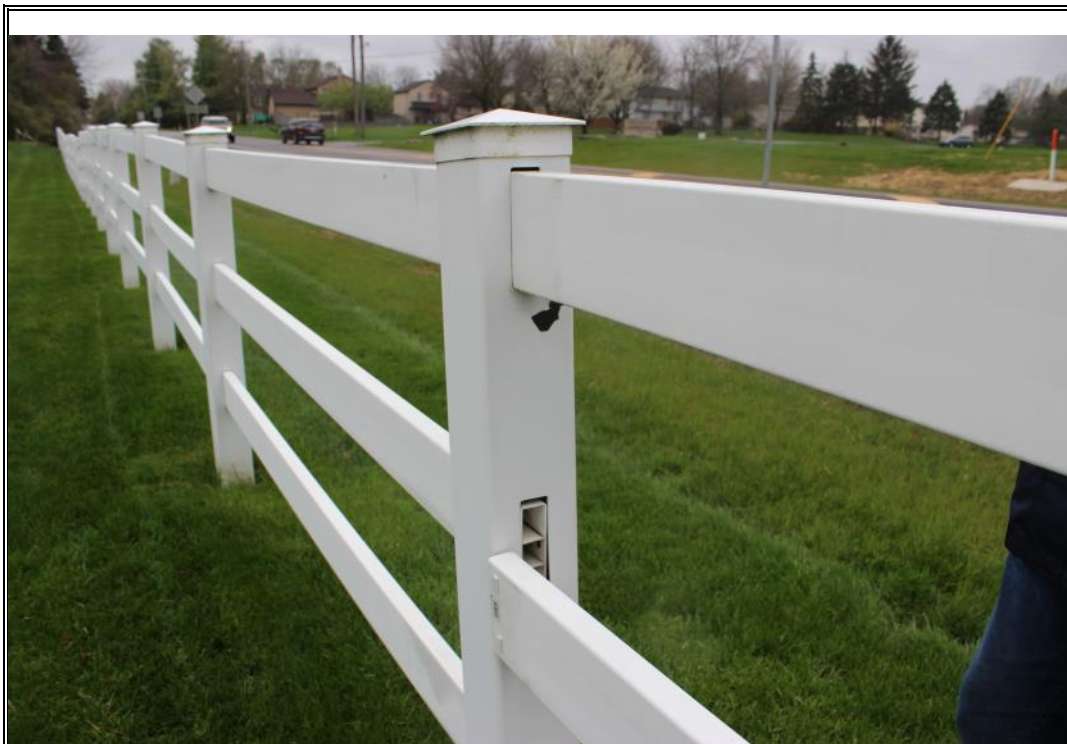
Photo Number
40

Description:
Example of minimal fence damage observed.

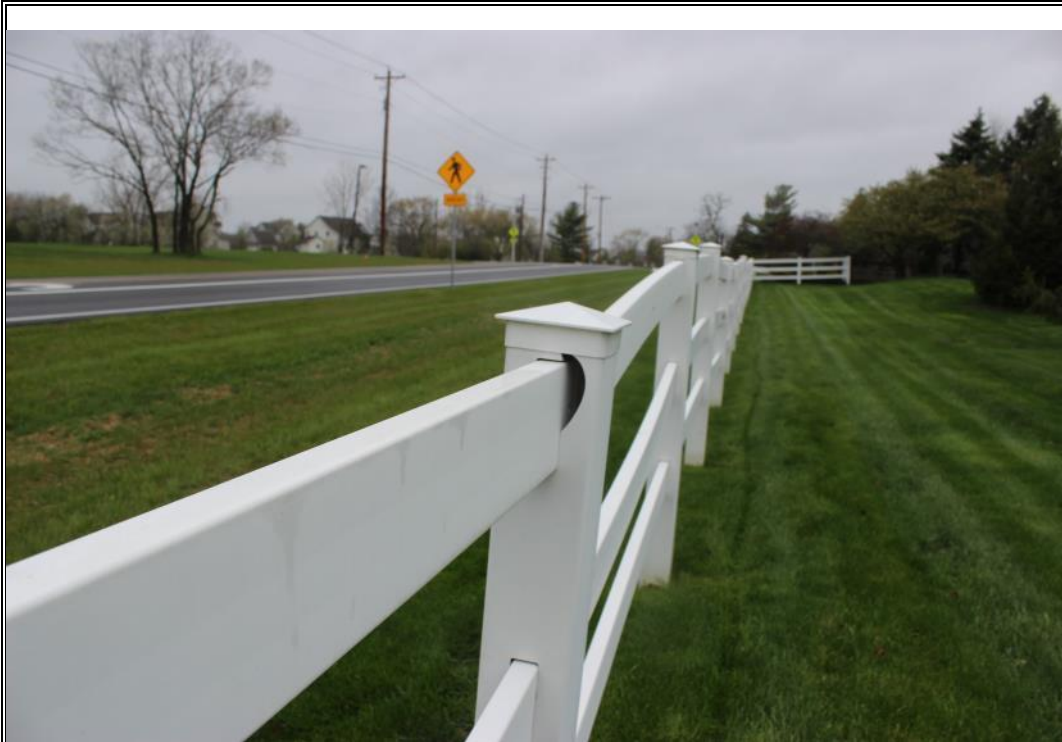
Photo Number
41

Description:
Example of minimal fence damage observed.

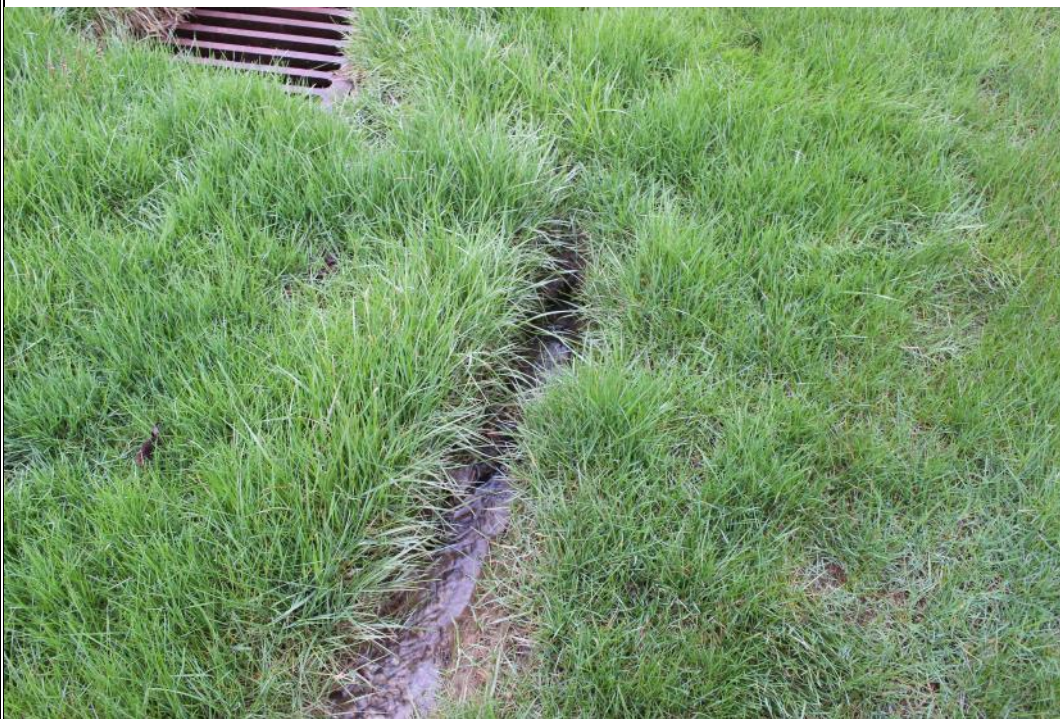
Photo Number
43

that up to 4 to 5 feet of water depth may be present after heavy storm water events in this detention pond. The entire surface of the detention pond is covered with grass and was in good condition. Only one area of ground erosion was noted near the south surface drain grate. The two surface grates in the detention pond feed to an underground storm water pipe which generally directs storm water to the northeast under the street, ultimately to the east of the community. The north most surface grate receives water from underground storm water pipe from the east and west. Funds to periodically repair the surface of the detention pond have been included in the study.

Description:
The surface of the detention pond was well vegetated, but this area near one of the two surface grates was experiencing channel erosion.
