RESERVE FUND STUDY

**LIBERTYDALE HOMEOWNERS ASSOCIATION
POWELL, OHIO**

*Revision 0
OCTOBER 7, 2022*

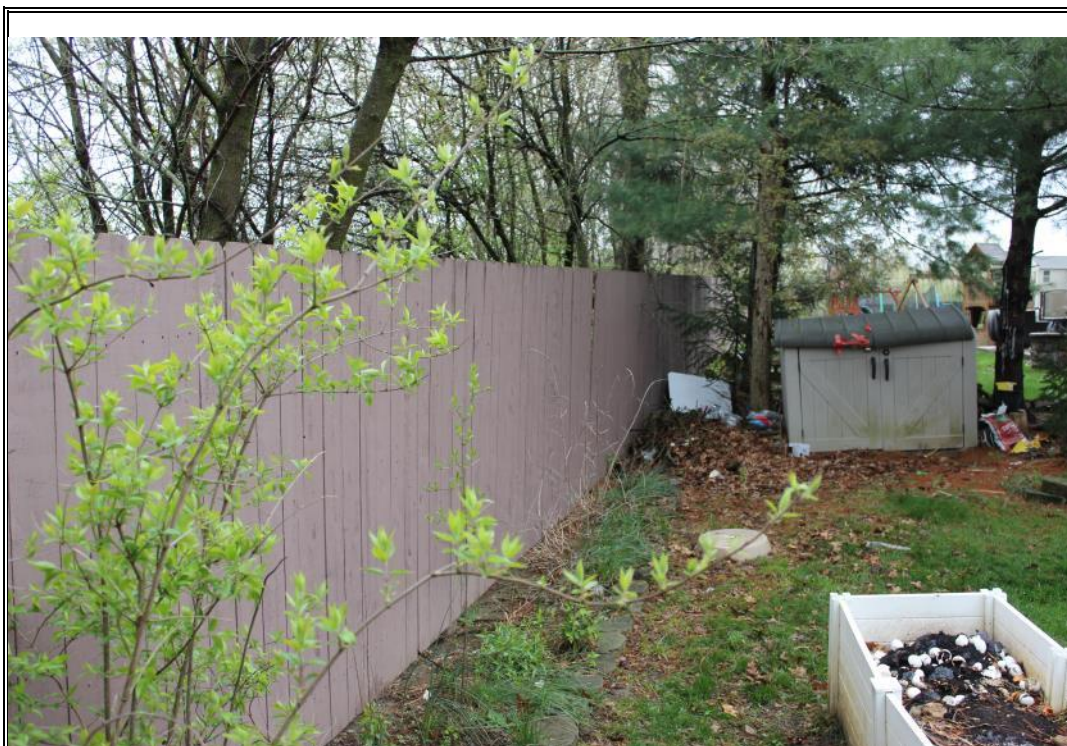
Photo Number
11

Description:
Six feet tall wood
privacy fence
along
approximately half
of the west border
of the community.
This is the north
end of the fence,
looking south.

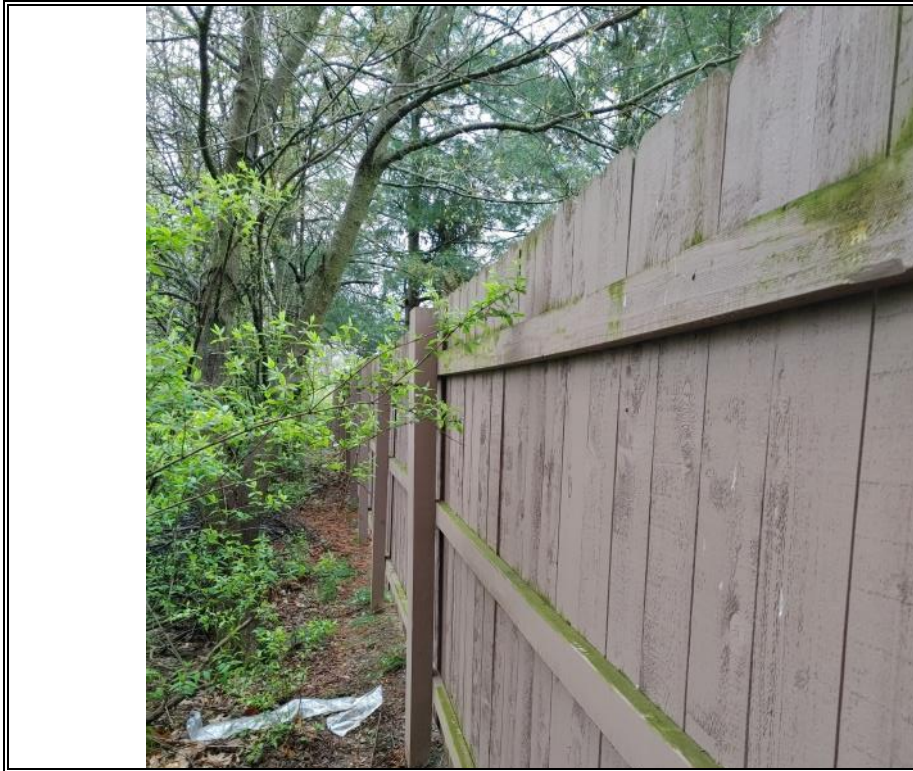
Example of the wood privacy fence construction. Each panel is approximately 8 feet long and supported by 4x4 posts at each end. 2x4 wood boards support the pickets.

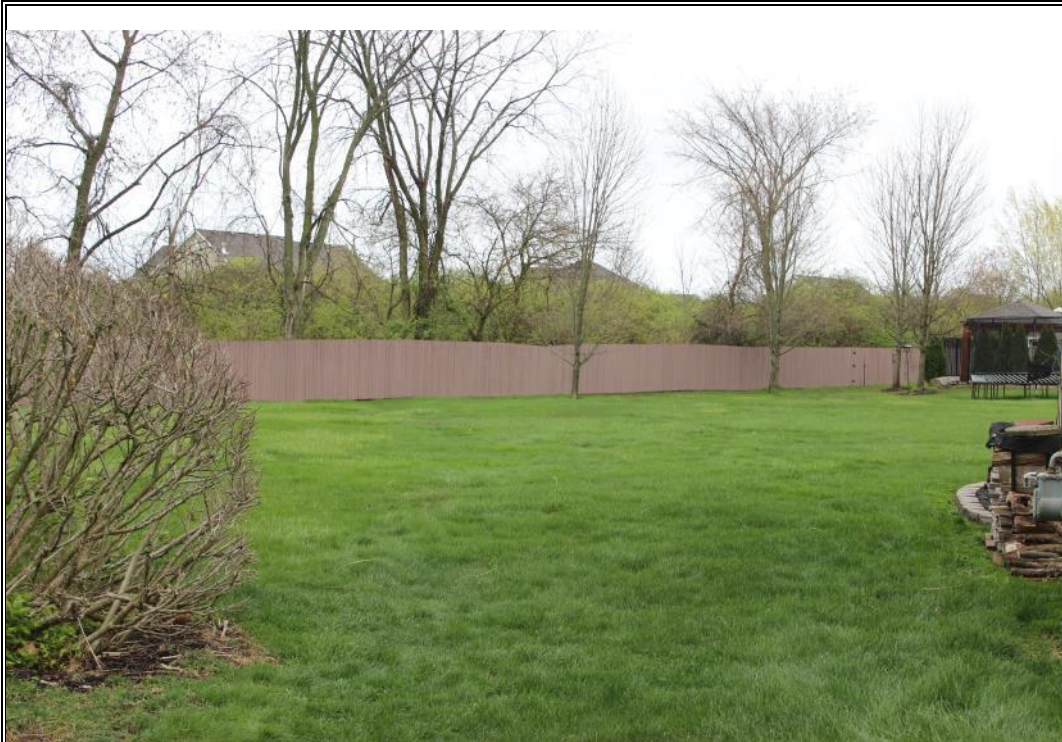
Description:
Mid-point along the wood privacy fence, looking east. Note the fence gate near the right end of the photo.

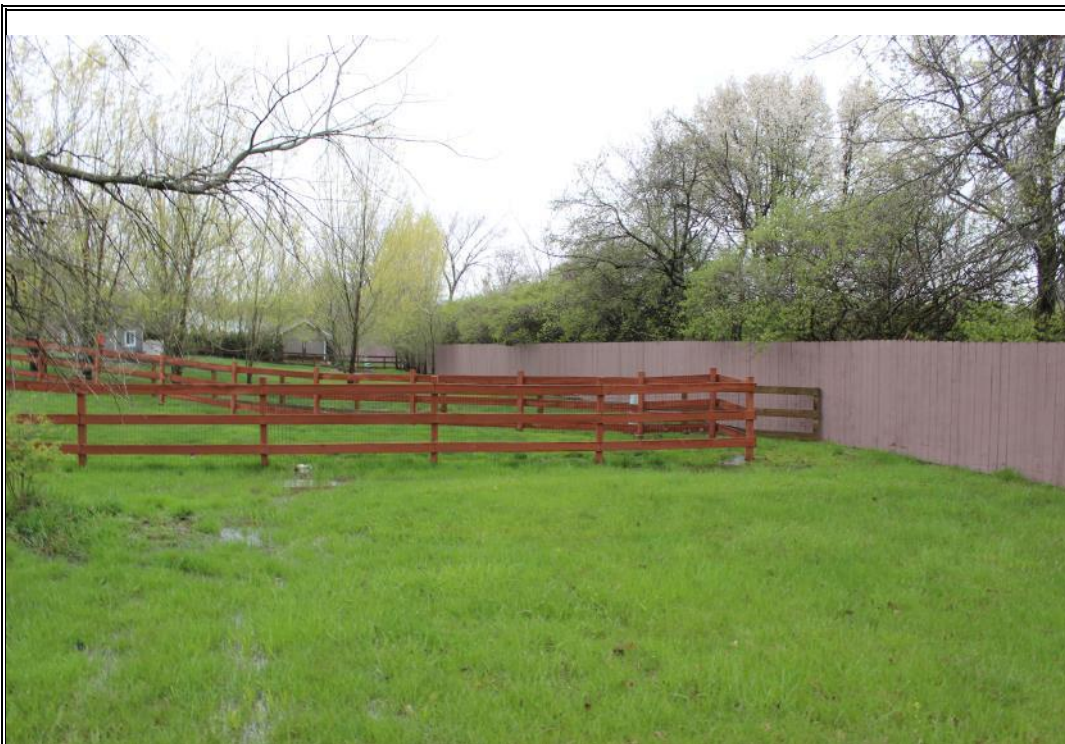
17

South end of the wood privacy fence, looking north.

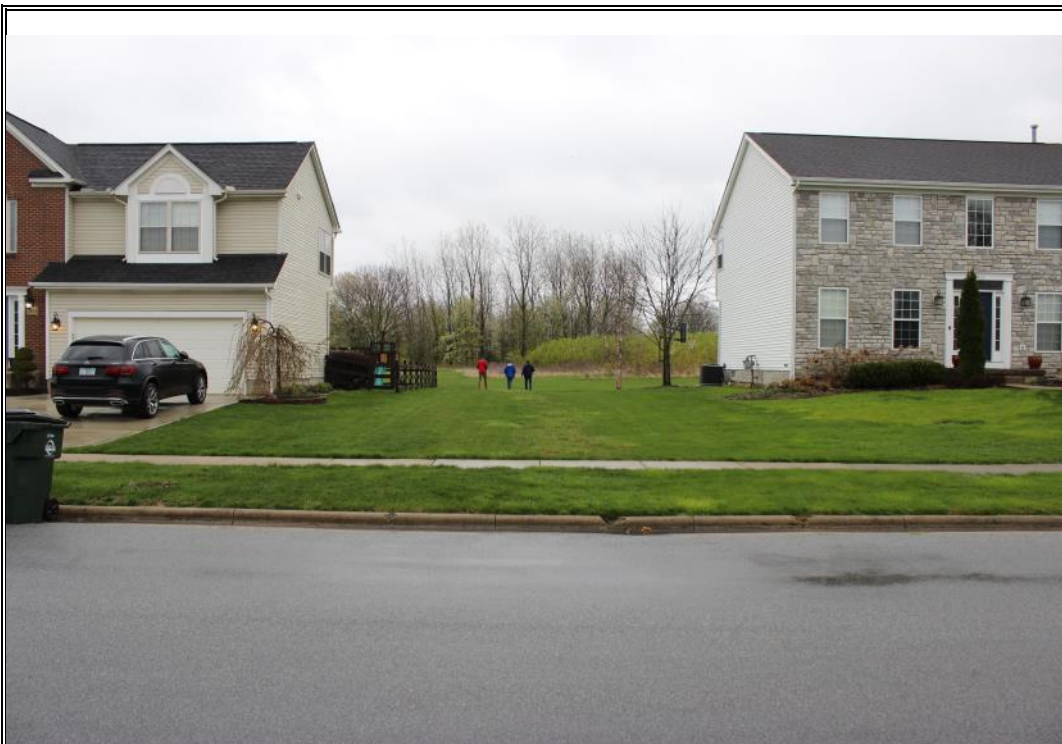
Description:
Part of the
community
southeast nature
parcel between
adjacent unit
parcels. Looking
east. The sidewalk
on this portion of
the parcel is an
association
component.

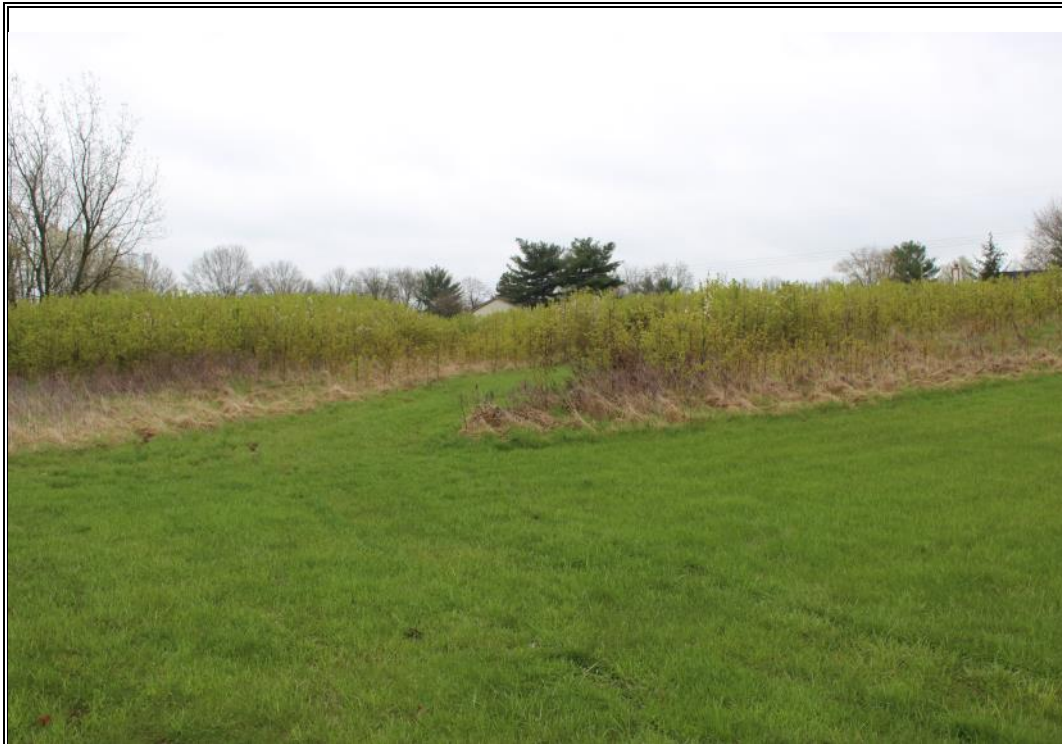
Description:
Northwest corner of the community nature area parcel. Looking southeast towards the entrance to the mowed nature path. It was reported that trespassing had been occurring in recent years in the nature area.

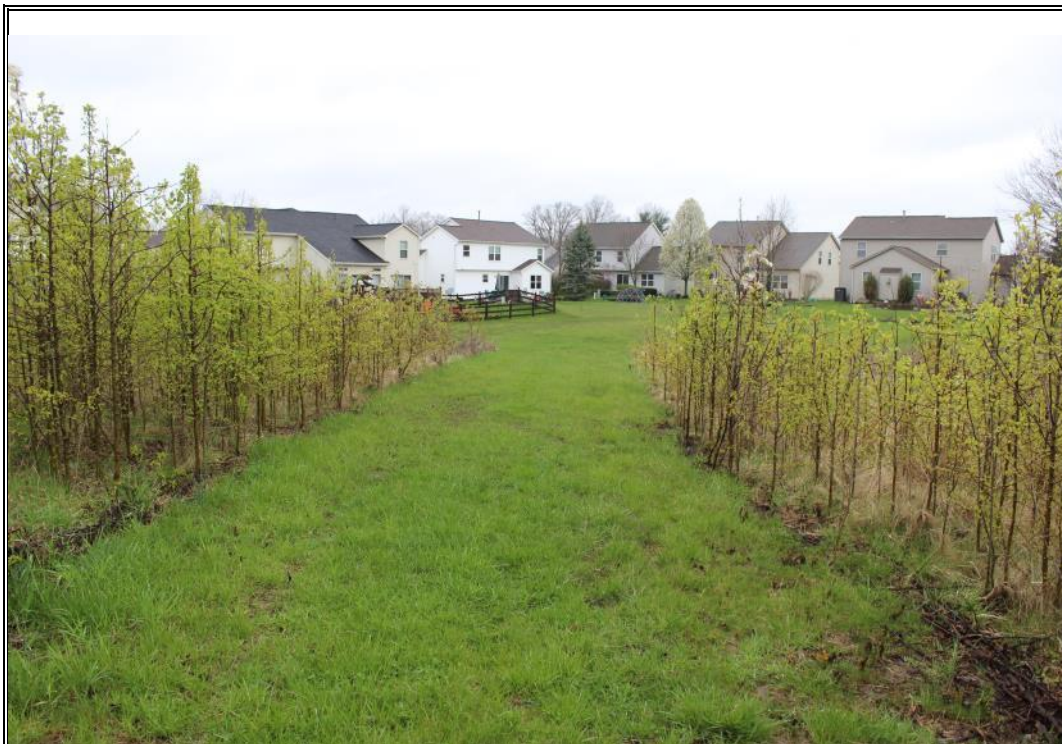
Description:
Looking northwest from the nature path. Note that a majority of the nature area used to be bush-hogged regularly, but has more recently been let to grow as seen in this photo on each side of the nature path.

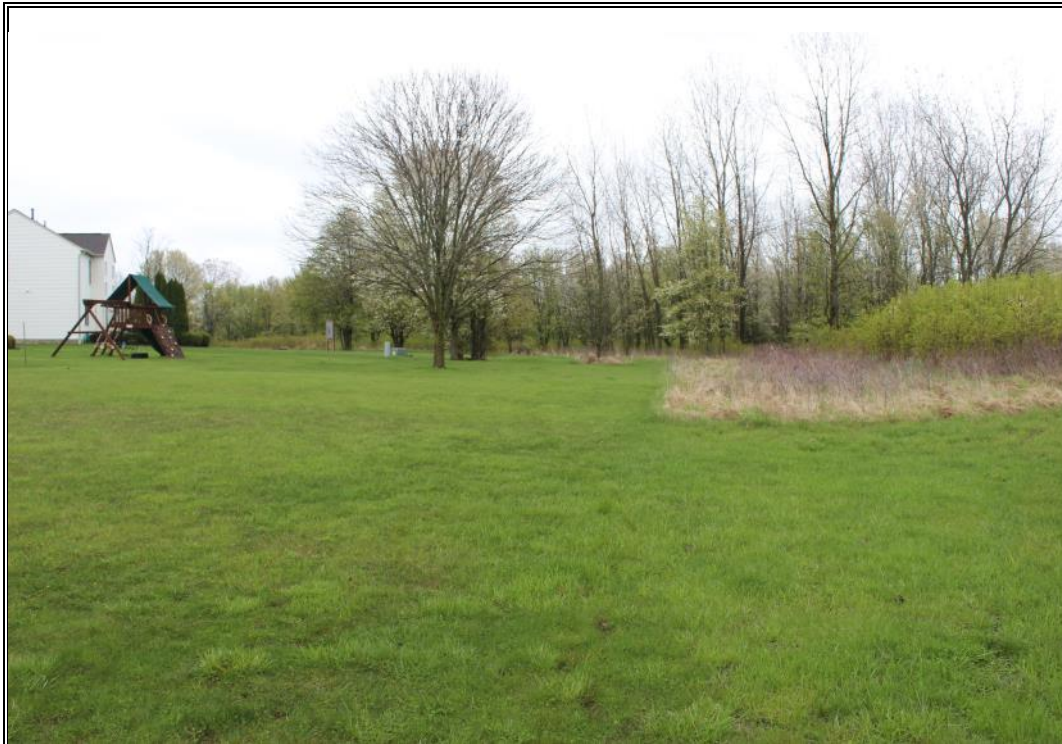
Description:
An approximately 50 foot mowed buffer zone to the homes on the north side of the nature area parcel. This photo is looking from the west end of the parcel, looking east.

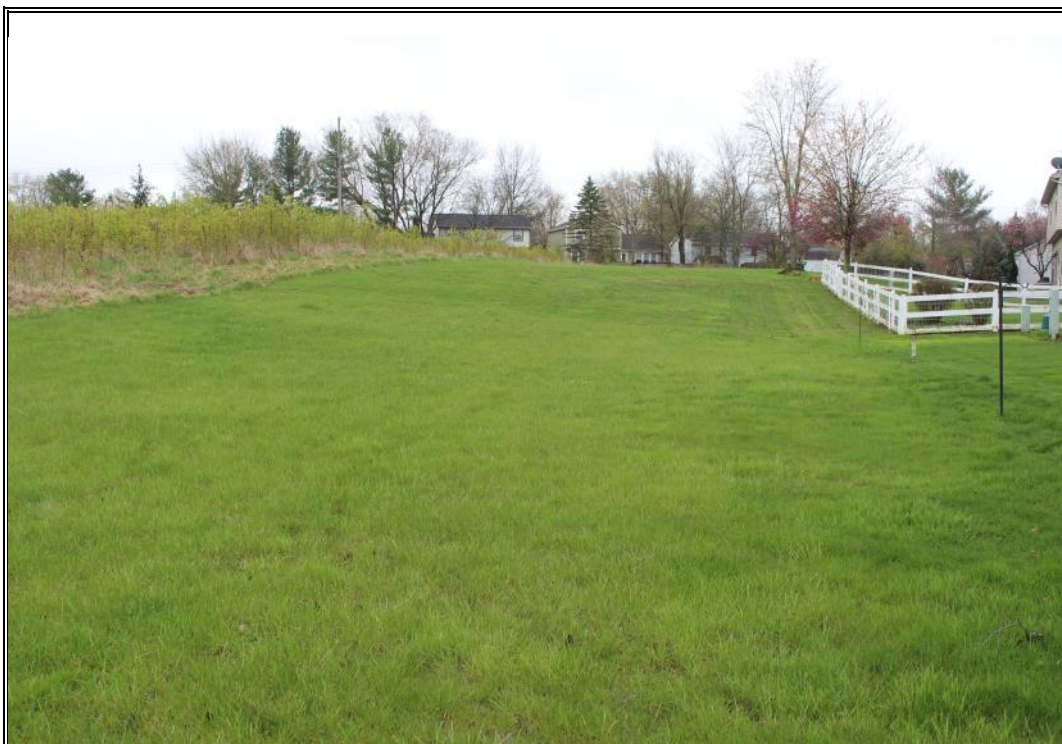
Description:
An approximately 50 foot mowed buffer zone to the homes on the west side of the nature area parcel. This photo is looking from the north end of the parcel, looking south.

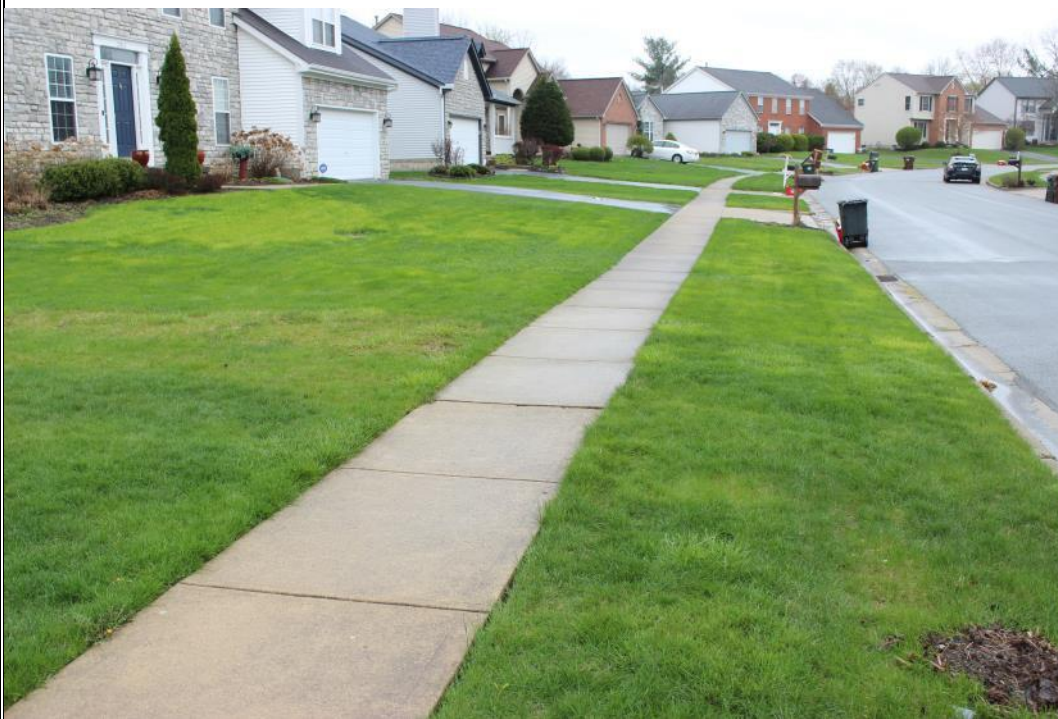
Description:
Four feet wide by 31 feet long concrete sidewalk along the roadway at the nature area parcel entrance from the community.

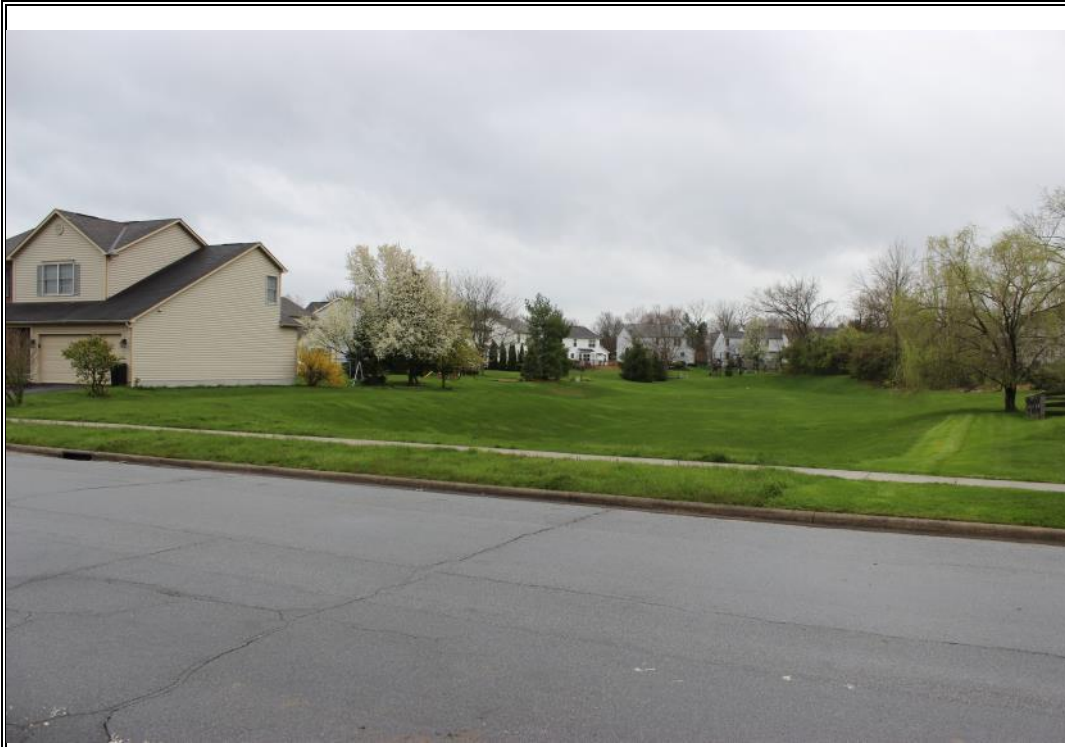
Description:
Four feet wide by 80 feet long concrete sidewalk along the roadway at the detention pond parcel.

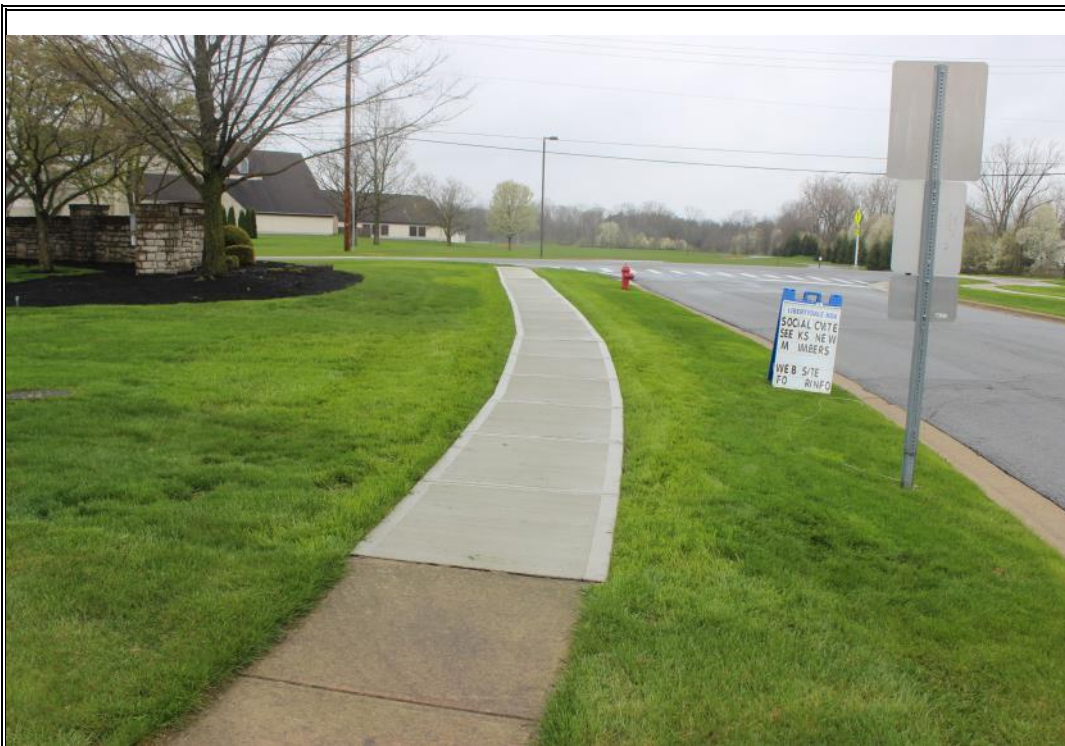
Description:
Four feet wide by 127 feet long concrete sidewalk along the roadway at the south side of the community entrance. This sidewalk was recently installed by the municipality as part of an adjacent road construction project.

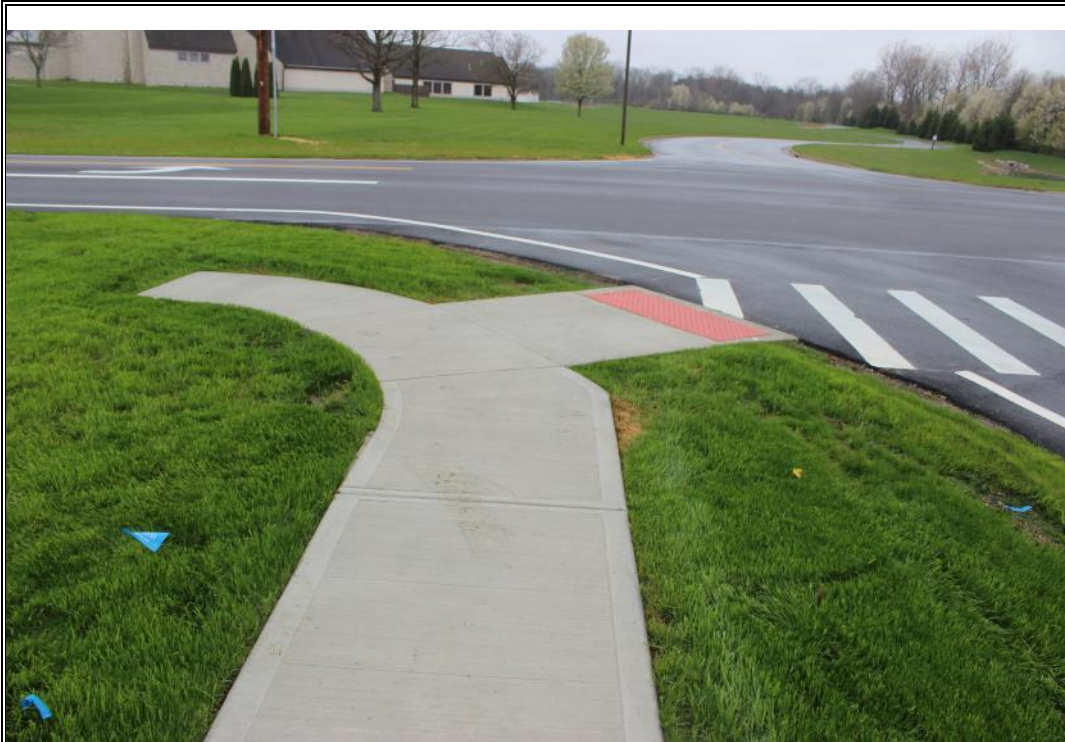
Description:
West end of the sidewalk south of the community entrance. ADA warning (tactile) pads were installed.

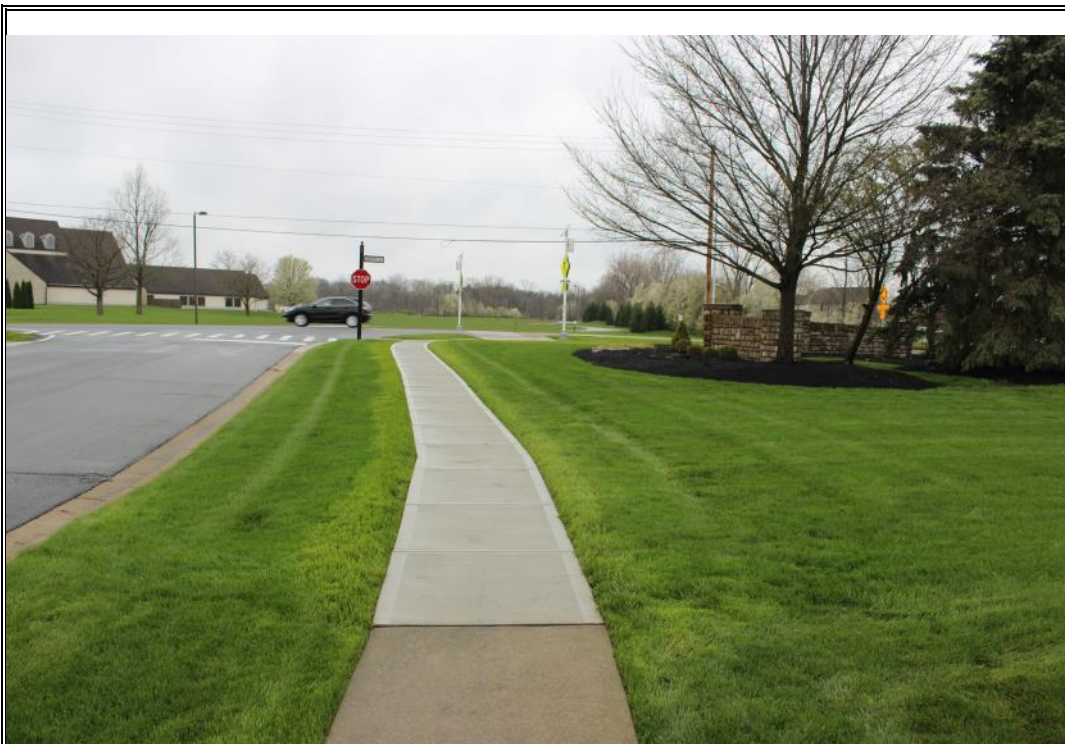
Description:
Four feet wide by 127 feet long concrete sidewalk along the roadway at the north side of the community entrance. This sidewalk was recently installed by the municipality as part of an adjacent road construction project.

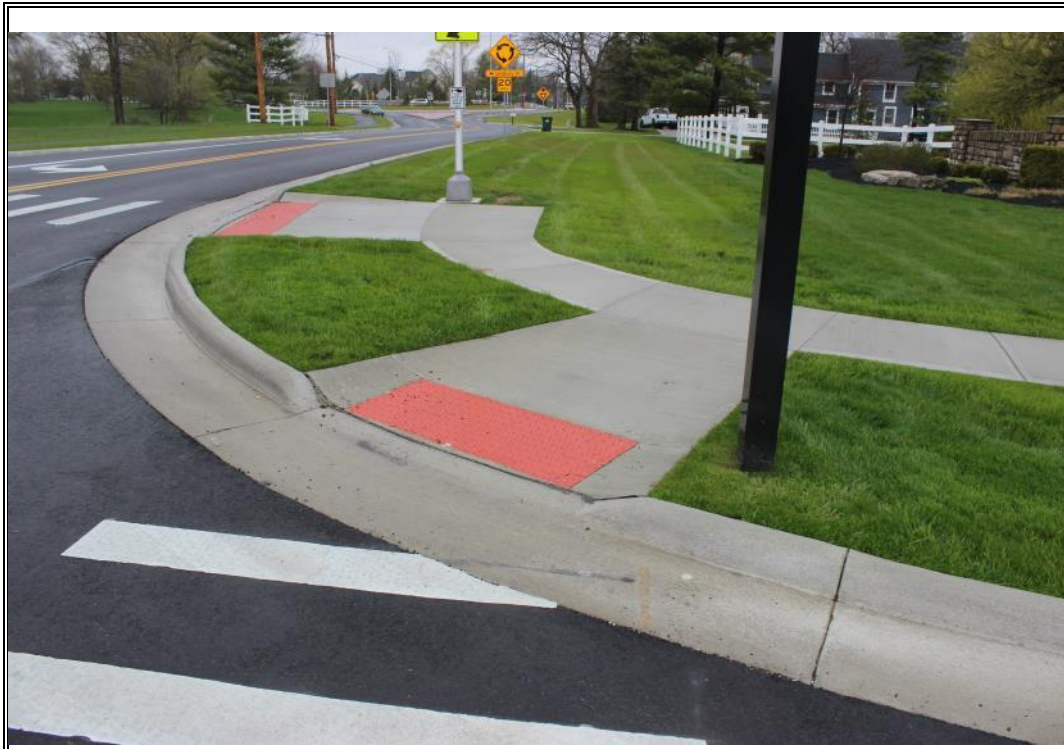
Description:
West end of the sidewalk north of the community entrance. ADA warning (tactile) pads were installed.

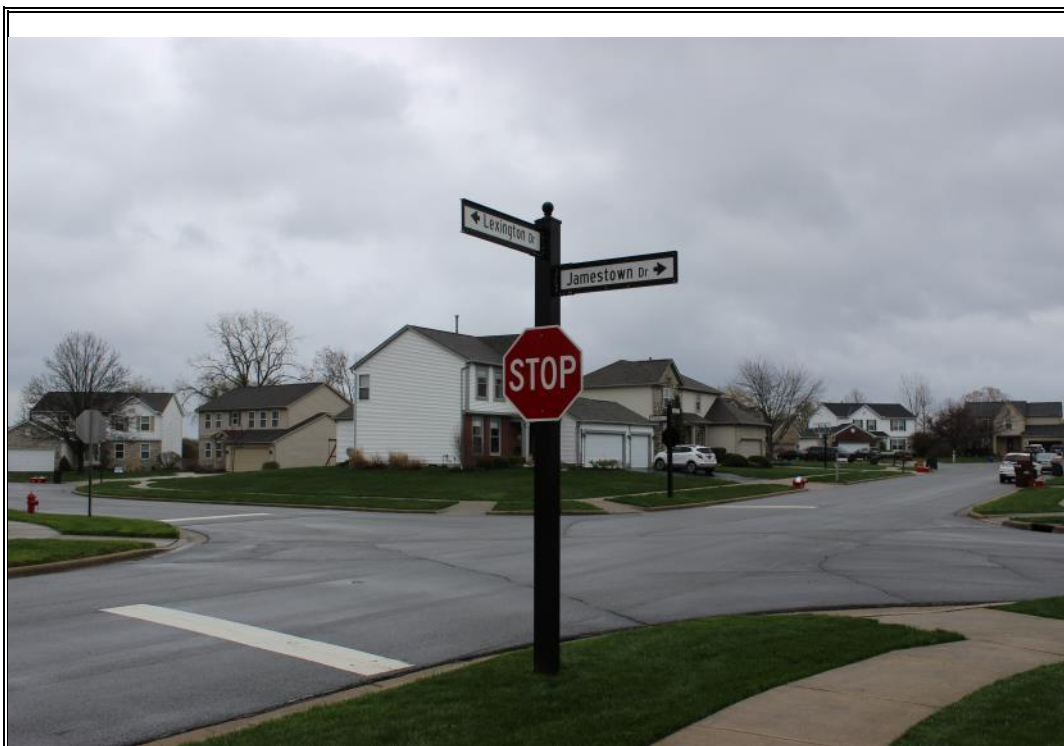
Description:
Recently installed signage including street signs, stop sign, and black aluminum wood post cover. The community had this signage installed.

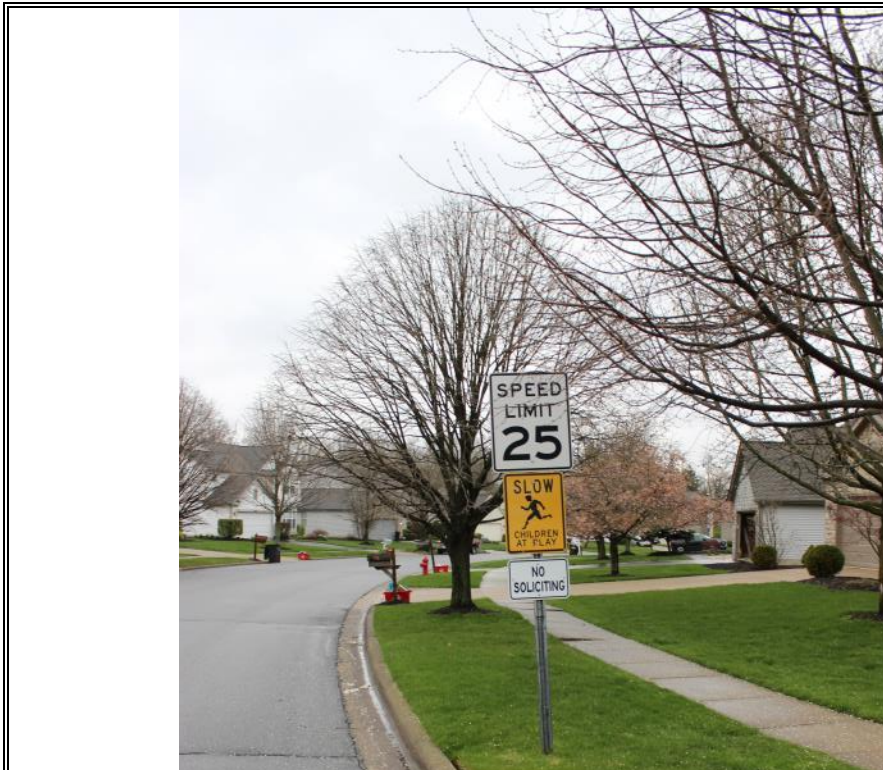
Description:
Example of u-channel mounted metal signage throughout the community. This signage is the responsibility of the local municipality.

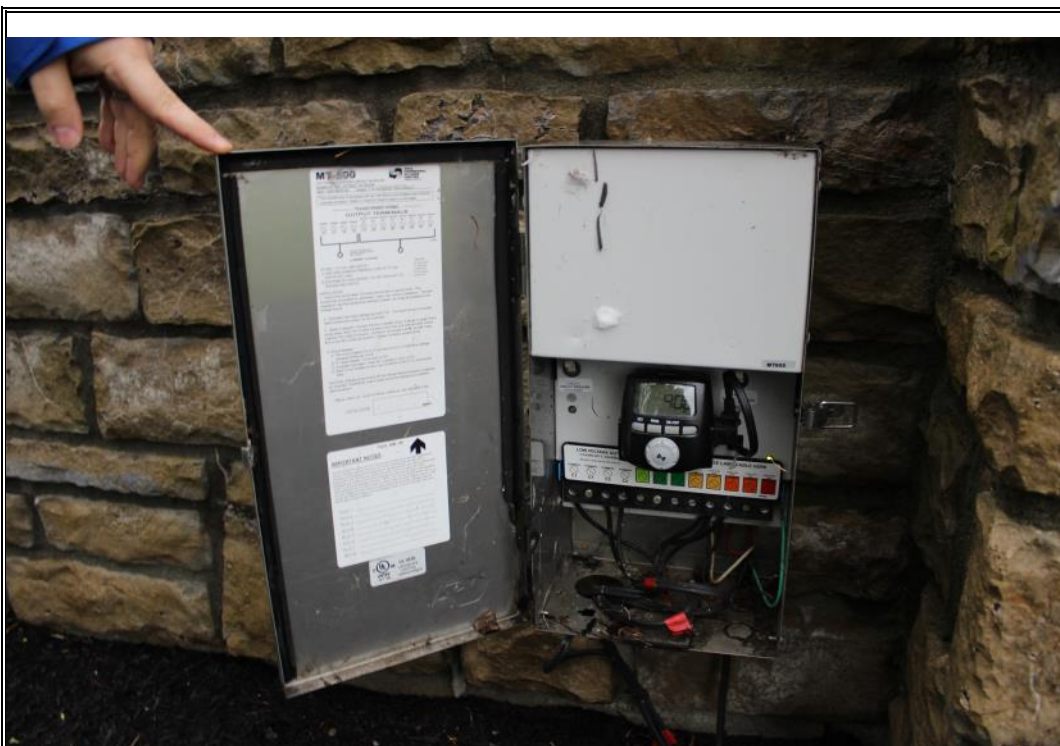
Description:
Low voltage lighting system control panel box at the community entrance.

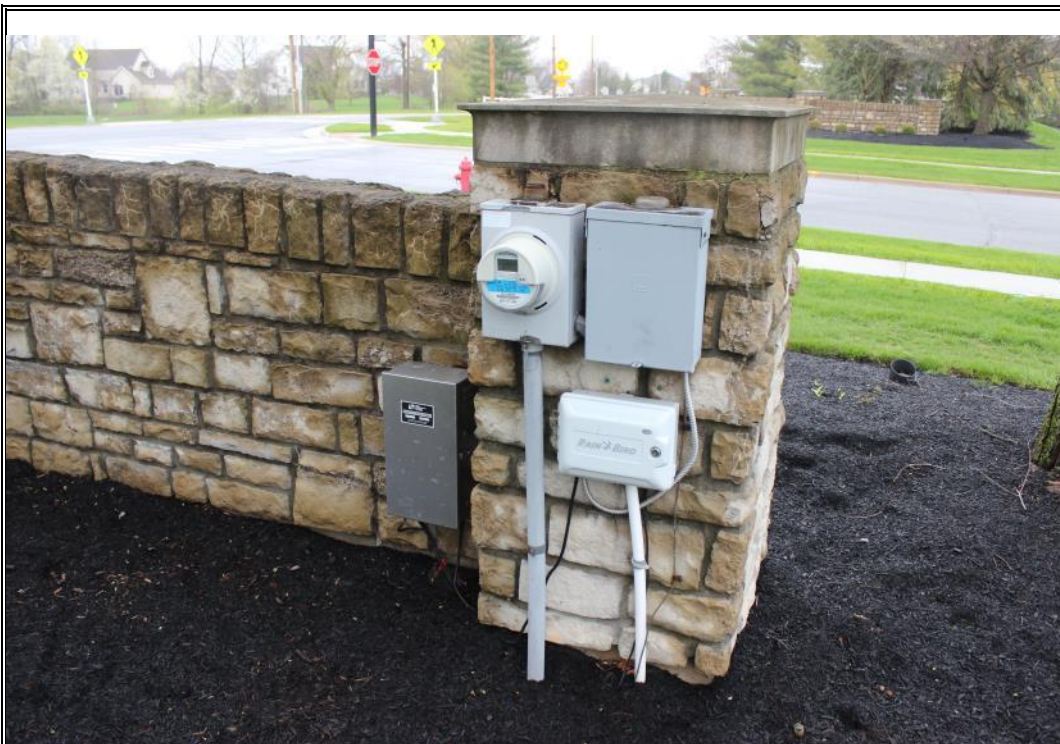
Description:
Power meter, low voltage lighting control box, breaker panel and irrigation system control box at the east end of the stone wall south of the community entrance.

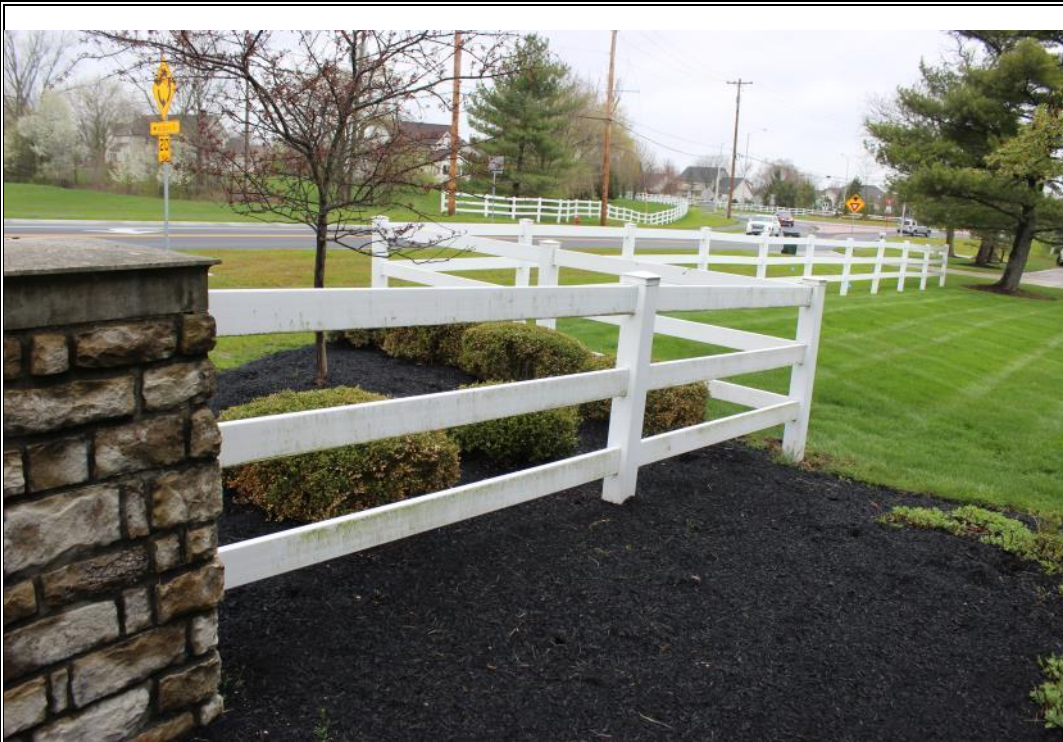
Description:
White polyvinyl chloride (PVC) fence north of the community entrance.

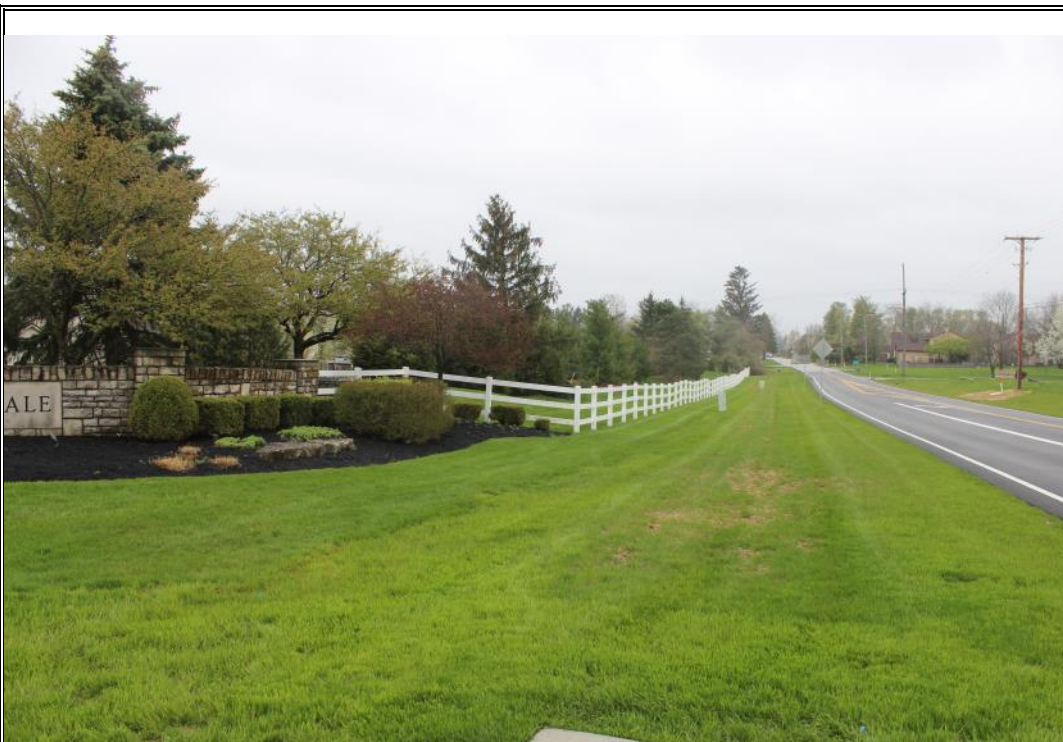
Description:
White polyvinyl chloride (PVC) fence south of the community entrance.

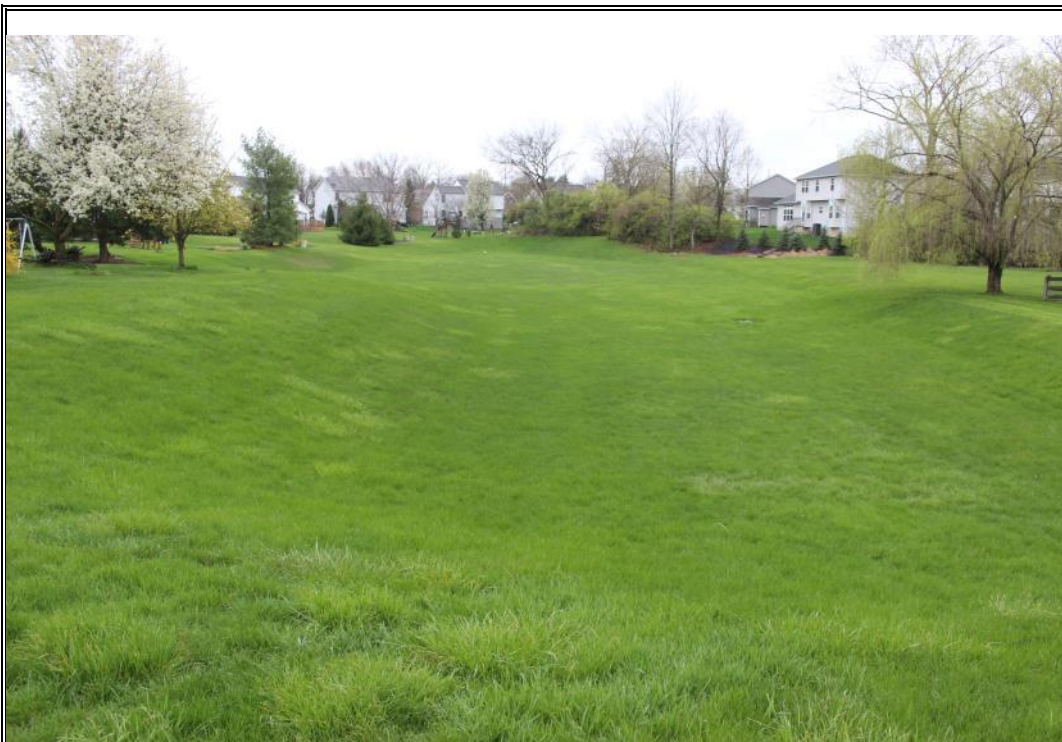
Description:
Detention pond parcel near the center of the community. This photo is looking south. This sunken area of ground retains community runoff water during heavy storm events.

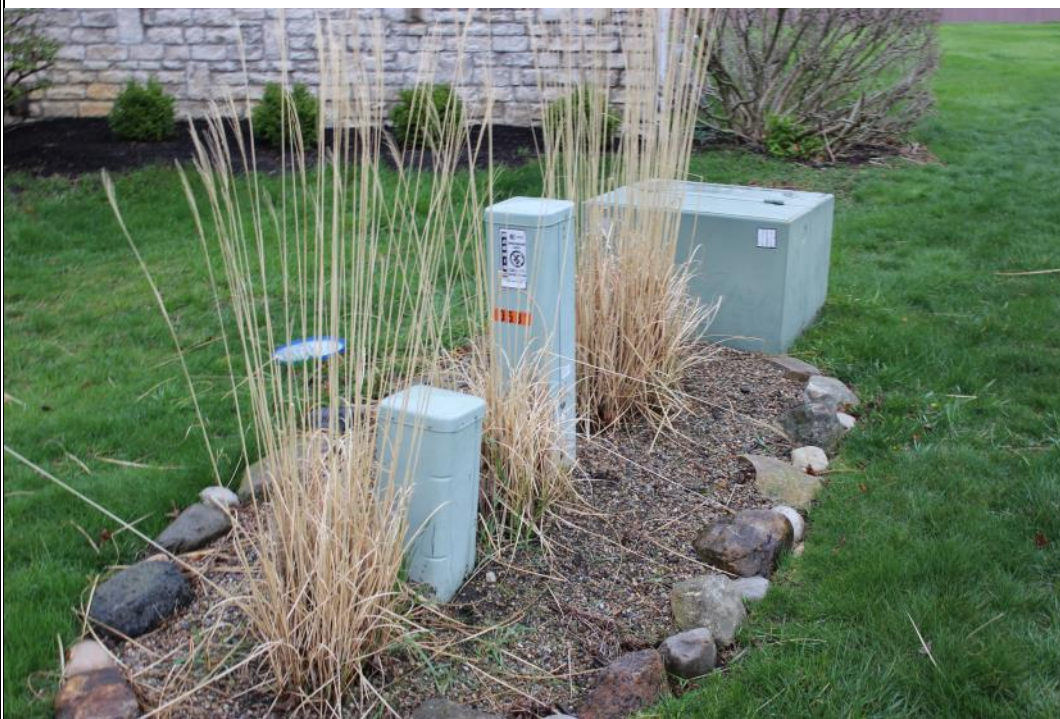
Description:
Example of the power transformer box (large box at the rear of the photo) that serves the adjacent homes with electricity.
